## NEAR SURFACE TEMPERATURE MONITORING INVESTIGATION CRINGILA PUBLIC SCHOOL - NW HOTSPOT

Summary Report  
06/05/2019 - 17/05/2019

NSW Department  
of Education  
Cringila Public School

May 2019  
C107826: J153825: RC/TO

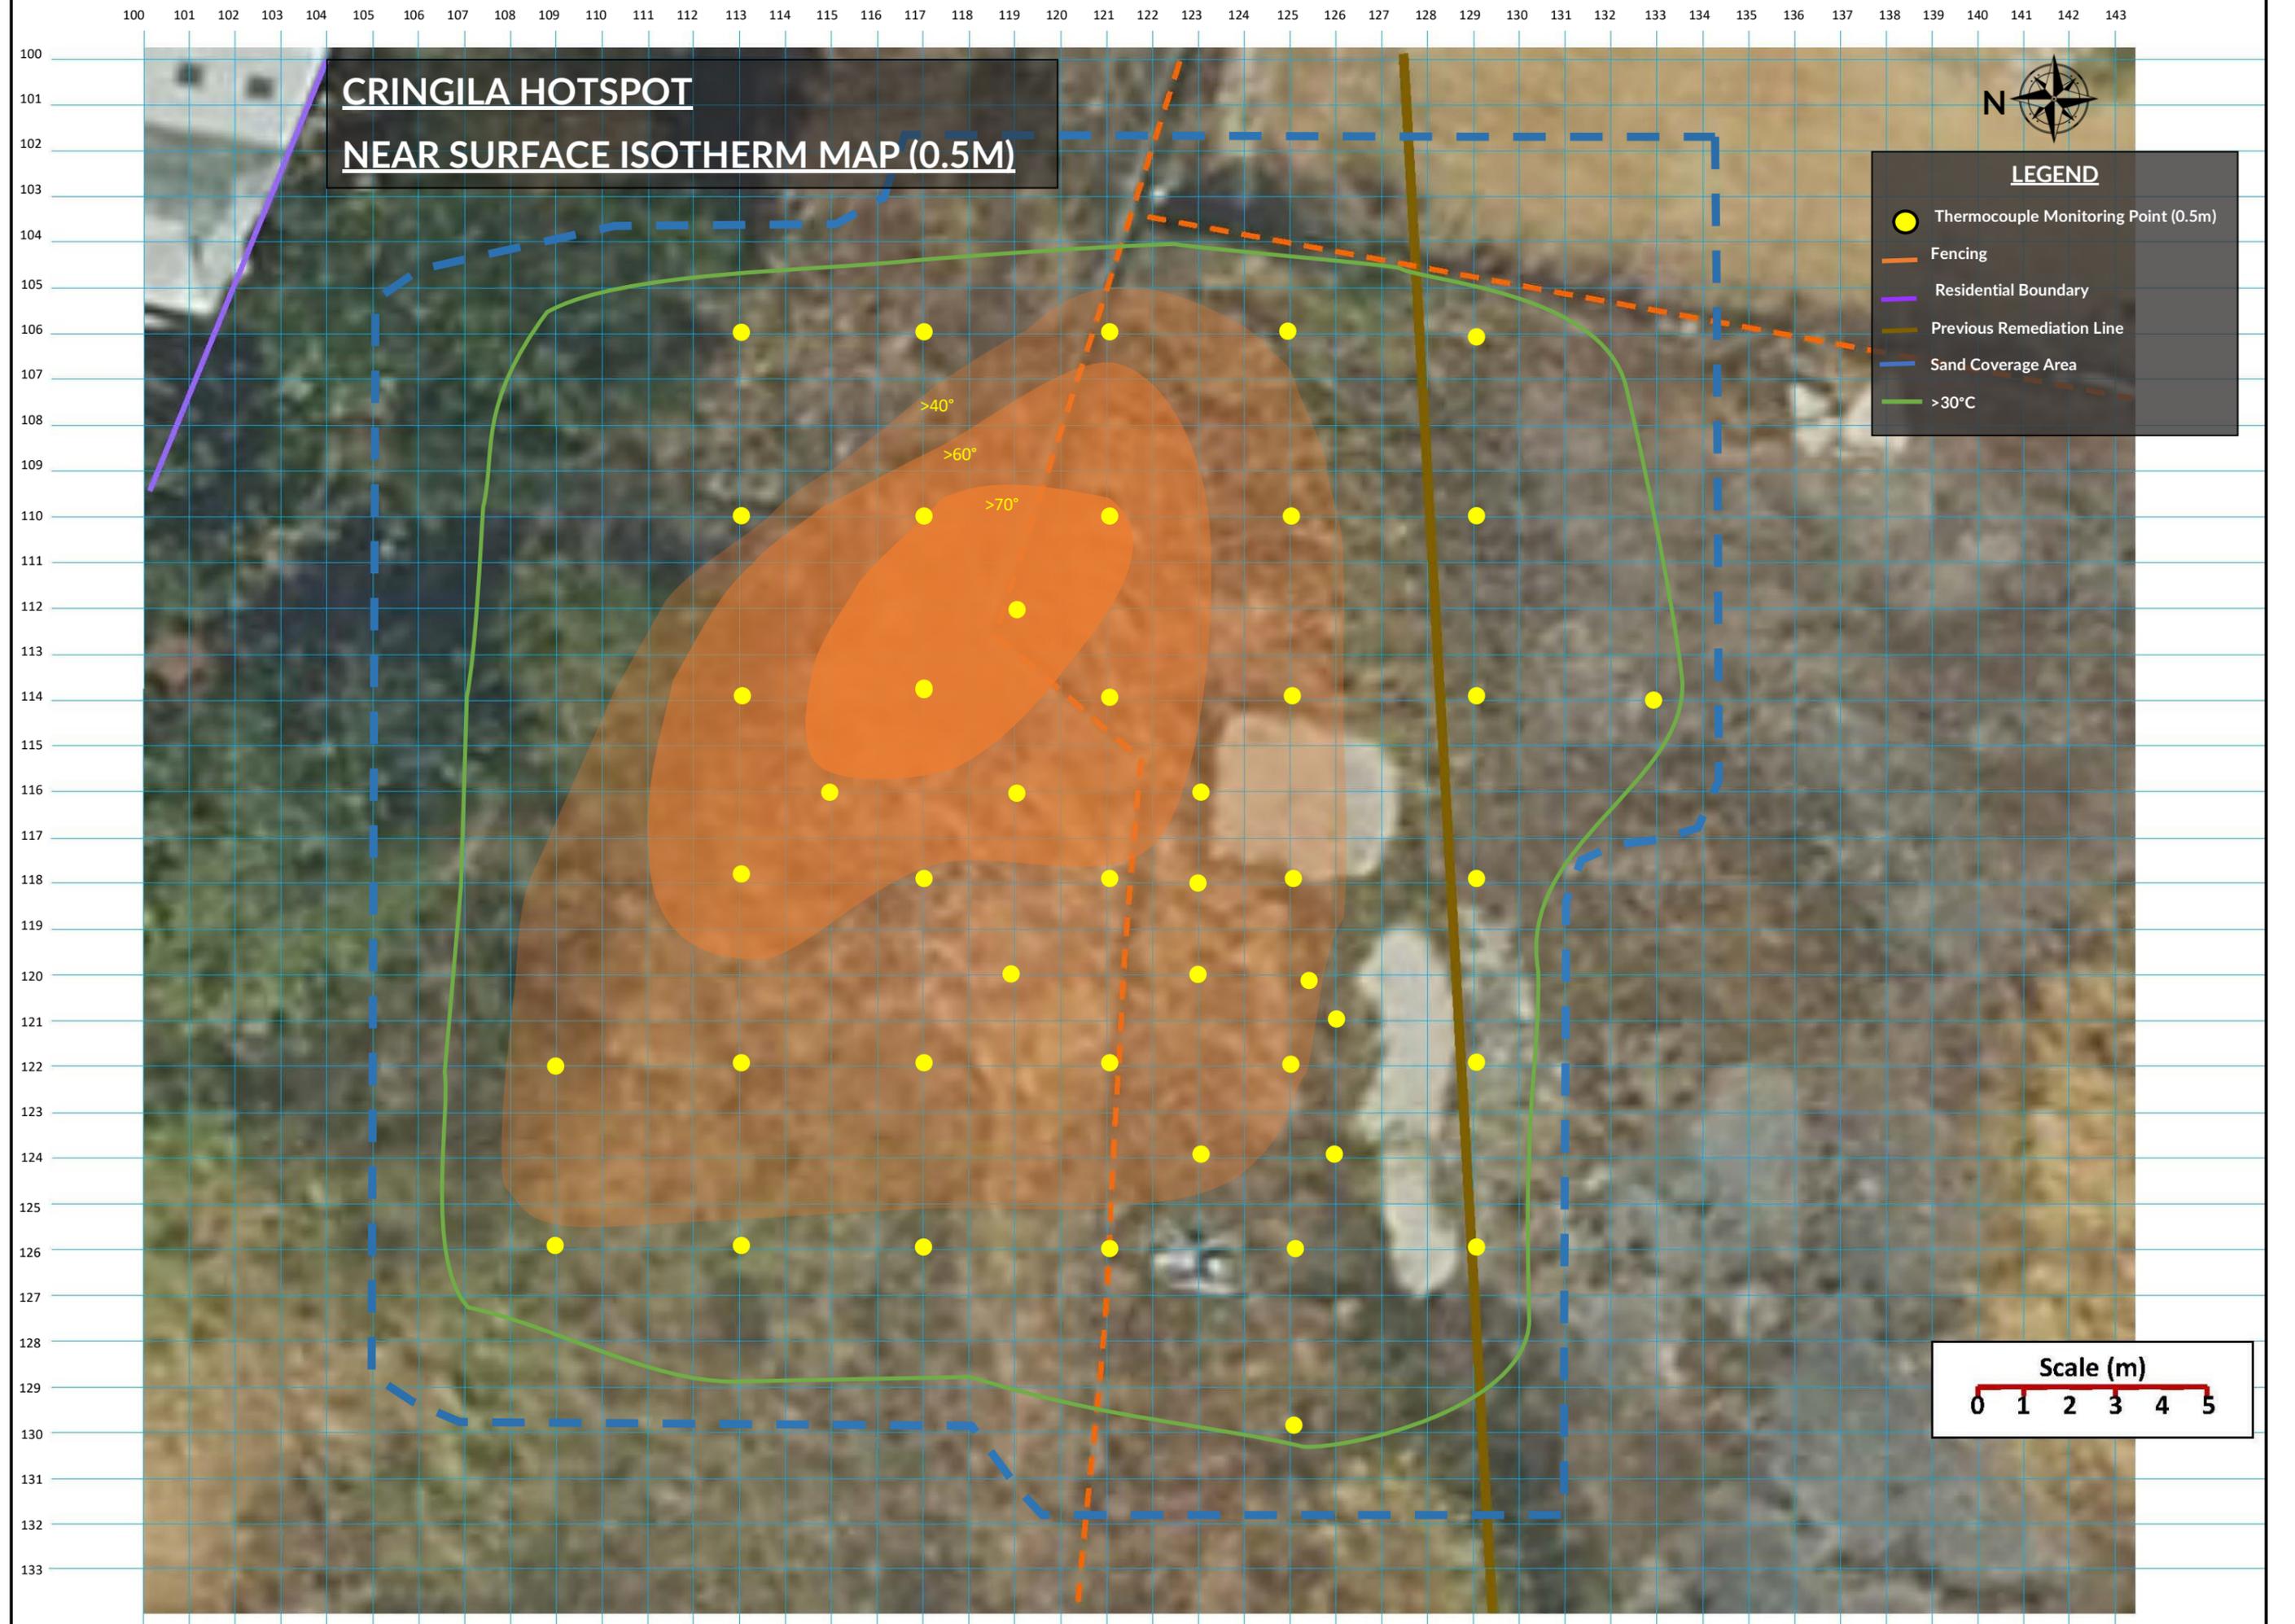
### Appendix B: Near Surface Temperature Isotherm Map (0.5m)

The isotherm map shows the general zone of influence for temperatures between 30°C and 75°C at 0.5m, coloured orange. The isotherm map suggests that the hotspot may extend deeper than 0.5m and that the increased temperature in these areas is a result of heat venting to the surface.

It is noted that temperature at the near-surface may be variable across the hotspot due to inconsistencies in the consolidation and compaction of subsurface materials.
