## NEAR SURFACE TEMPERATURE MONITORING CRINGILA PUBLIC SCHOOL - NW HOTSPOT

Weekly Summary Report  
04/06/2018 – 08/06/2018

Cringila Public School

June 2018  
C107826: J153825: RC

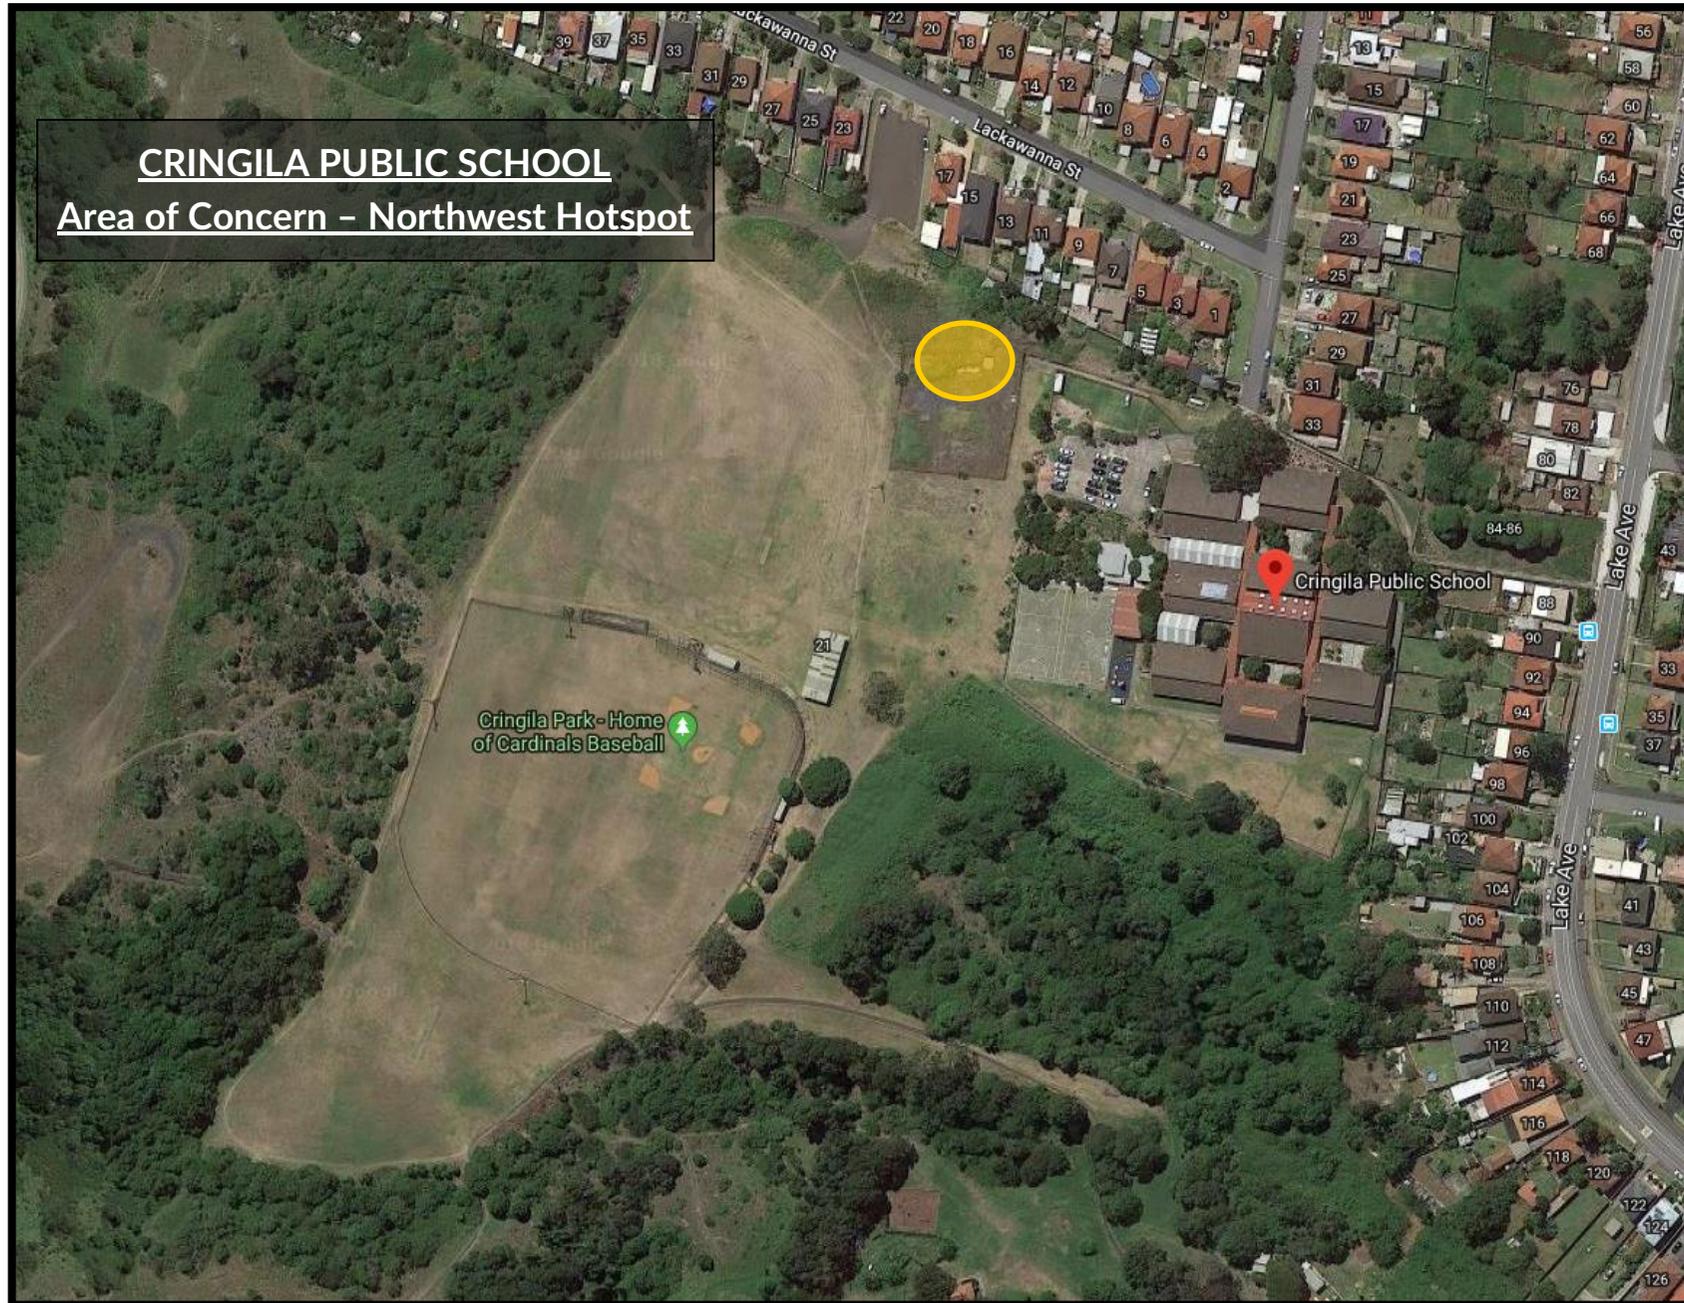
### Appendix A: Area of Concern – Northwest Hotspot Map

**CRINGILA PUBLIC SCHOOL**  
**Area of Concern - Northwest Hotspot**

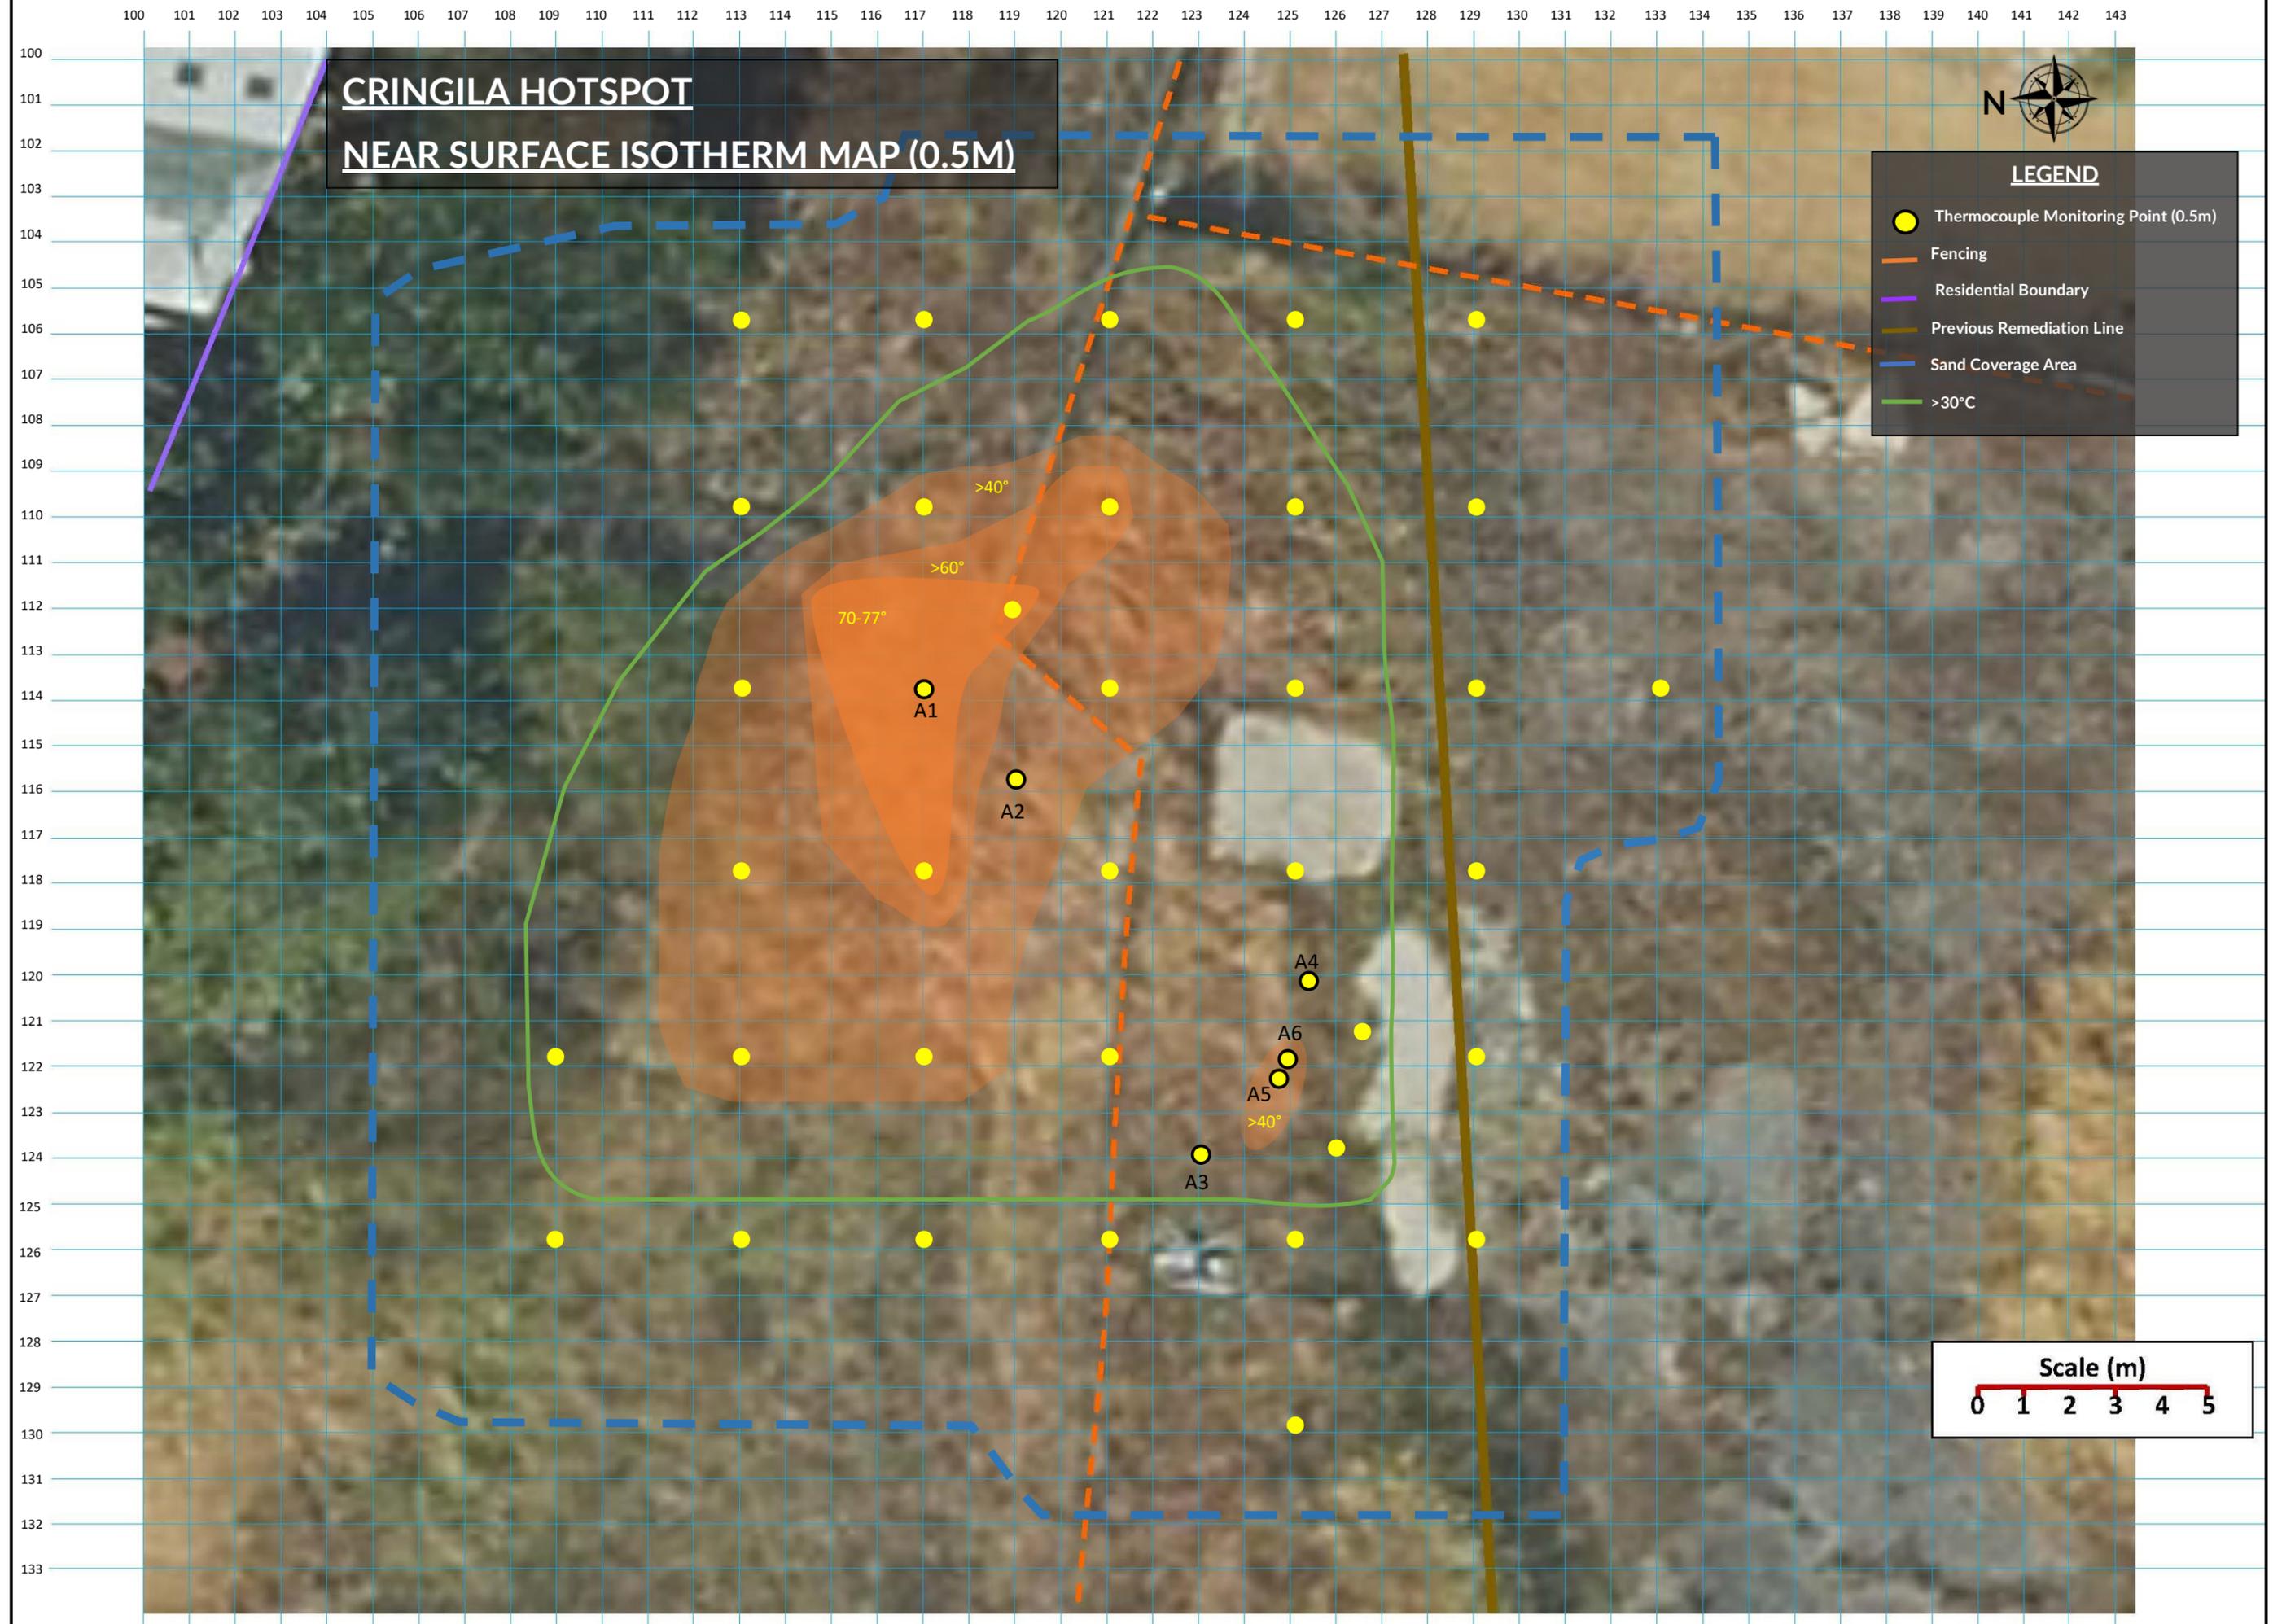
### Appendix C: Near Surface Temperature Isotherm Map (0.5m)

The isotherm mapping indicates a maximum temperature below 100°C beneath the small mound west of the concrete cap (monitoring point A5 at 0.3m depth) within the northwest hotspot. The isotherm map shows the general zone of influence for temperatures between 30°C and 80°C at 0.5m, coloured orange. The isotherm map suggests that the hotspot may extend deeper than 0.5m and that the increased temperature in these areas is a result of heat venting to the surface.

It is noted that temperature at the near-surface may be variable across the hotspot due to inconsistencies in the consolidation and compaction of subsurface materials.

# CRINGILA HOTSPOT NEAR SURFACE ISOTHERM MAP (0.5M)

It is recommended that weekly site inspections and recording are continued to monitor the surface and near surface temperatures surrounding the hotspot identified at the site.
