# Asbestos in Grounds, Asbestos Management Plan, Holroyd School, Merrylands, NSW

February 2011

NSW Public Works

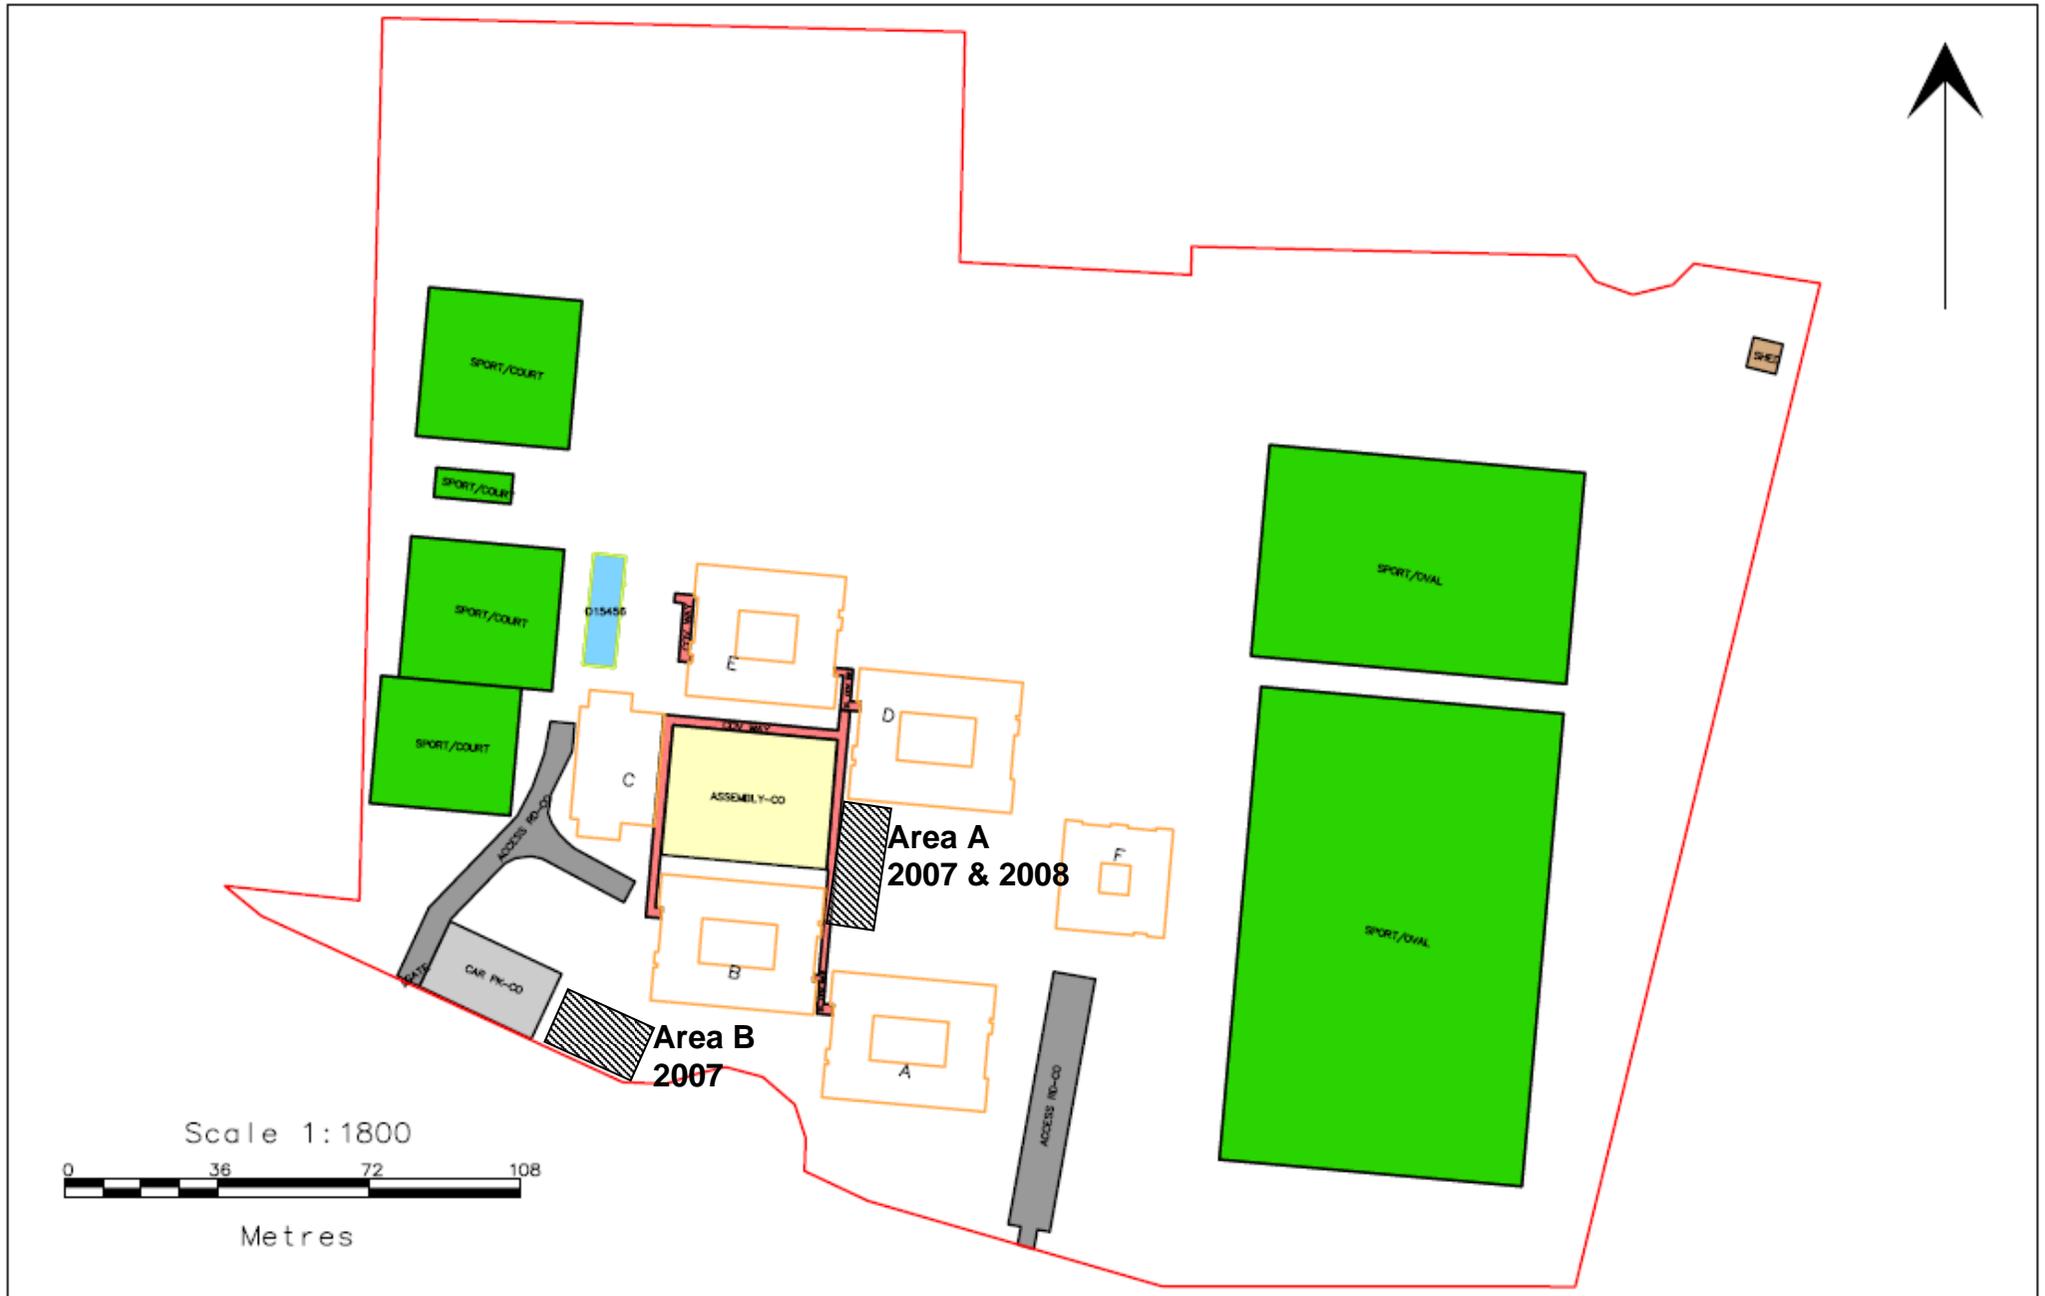
The remediated areas are shown in Figure 1.

Asbestos cement fragments may be present as a component of buried fill within the asbestos zone areas. Refer to Figure 1 site plan. A hygienist should be engaged to determine whether the asbestos within the Asbestos Zones is considered *bonded* or *friable* in accordance with the NSW WorkCover Authority 'Working with Asbestos, 2008'. This contains safety guidelines and requirements for work involving asbestos.

\*Refer to Figure 1 for detail of area locations

8424 — Holroyd High School  
Site Plan (11009)

Asbestos zones
