# **ASBESTOS IN GROUNDS**

ASBESTOS MANAGEMENT PLAN,  
NEWCASTLE EAST PUBLIC SCHOOL, 48  
BROWN STREET, THE HILL NSW

MAY 2018

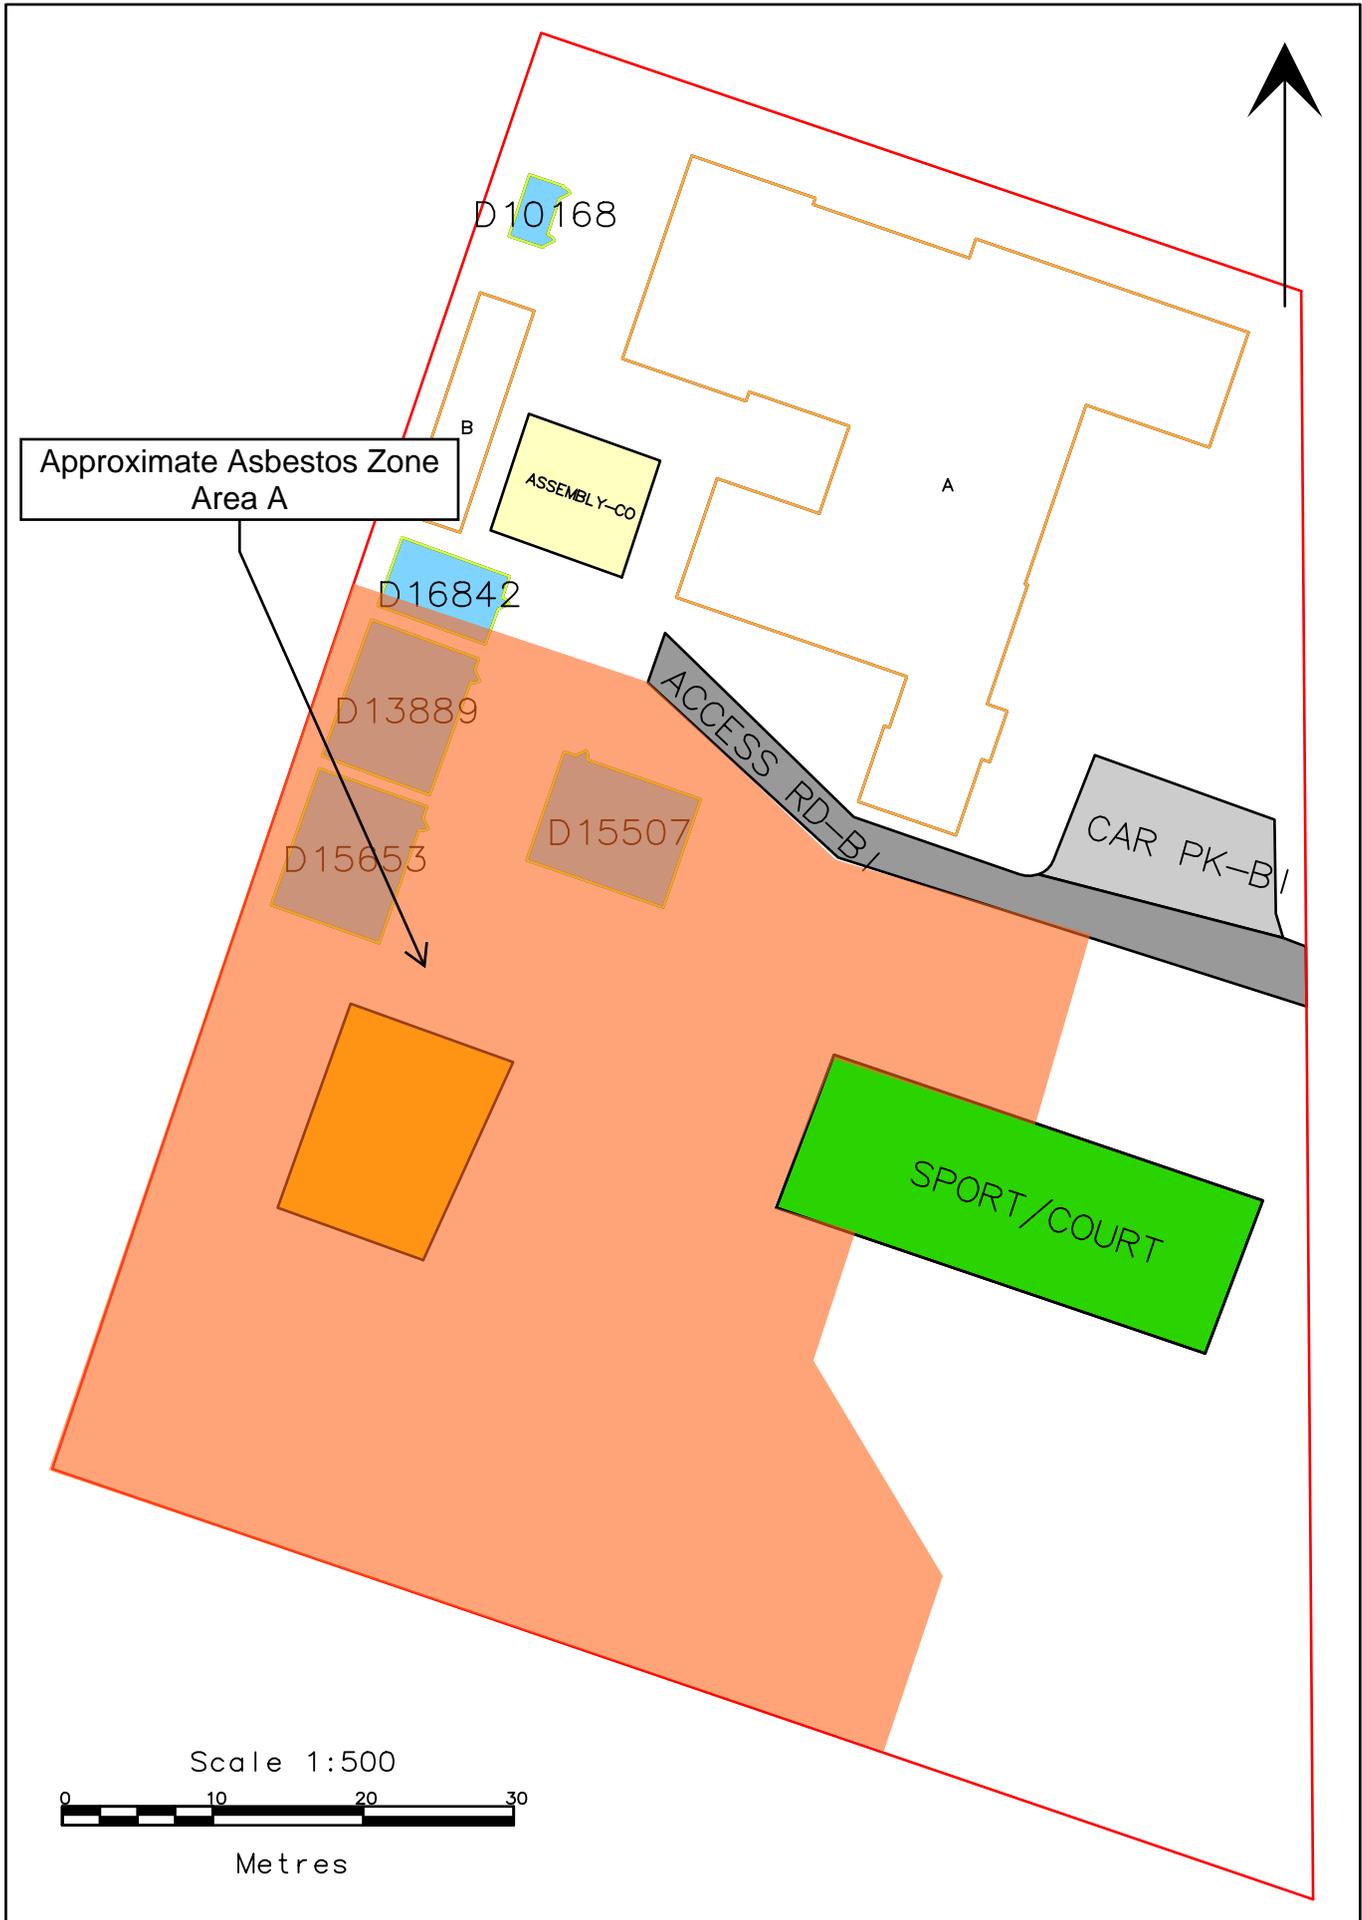
2736 – Newcastle East Public School  
Site Plan (11296)

Area A presented in Appendix A, Figure 1 illustrates the Asbestos Zone for the site. This area has been conservatively estimated using the location of surface lying asbestos cement fragments through each successive site visit by WSP and DoE representatives. It should be noted that to date, no subsurface investigation of the underlying soil/fill materials within the site has been completed.

Based on the surface lying asbestos cement fragments identified, it is assumed asbestos may be present as a component of buried fill within the Asbestos Zone and other areas of the site. Planned works within the Asbestos Zone or areas bordering the zone are to proceed with caution ensuring the following is undertaken:

- Adopting asbestos controls including PPE/RPE, supervision by a licensed asbestos assessor (LAA); performing airborne asbestos fibre monitoring; or
- Implementation of an unexpected finds protocol to ensure asbestos controls are adopted in the event that surface lying or buried asbestos cement fragments are identified.

Further assessment by a LAA is also recommended to determine the extent of the suspected contamination and whether the asbestos is considered non-friable or friable.
