Asbestos in Grounds, Asbestos Management Plan, Corrimal High School, Corrimal, NSW

March 2013

NSW Public Works

2171479A PR_6945

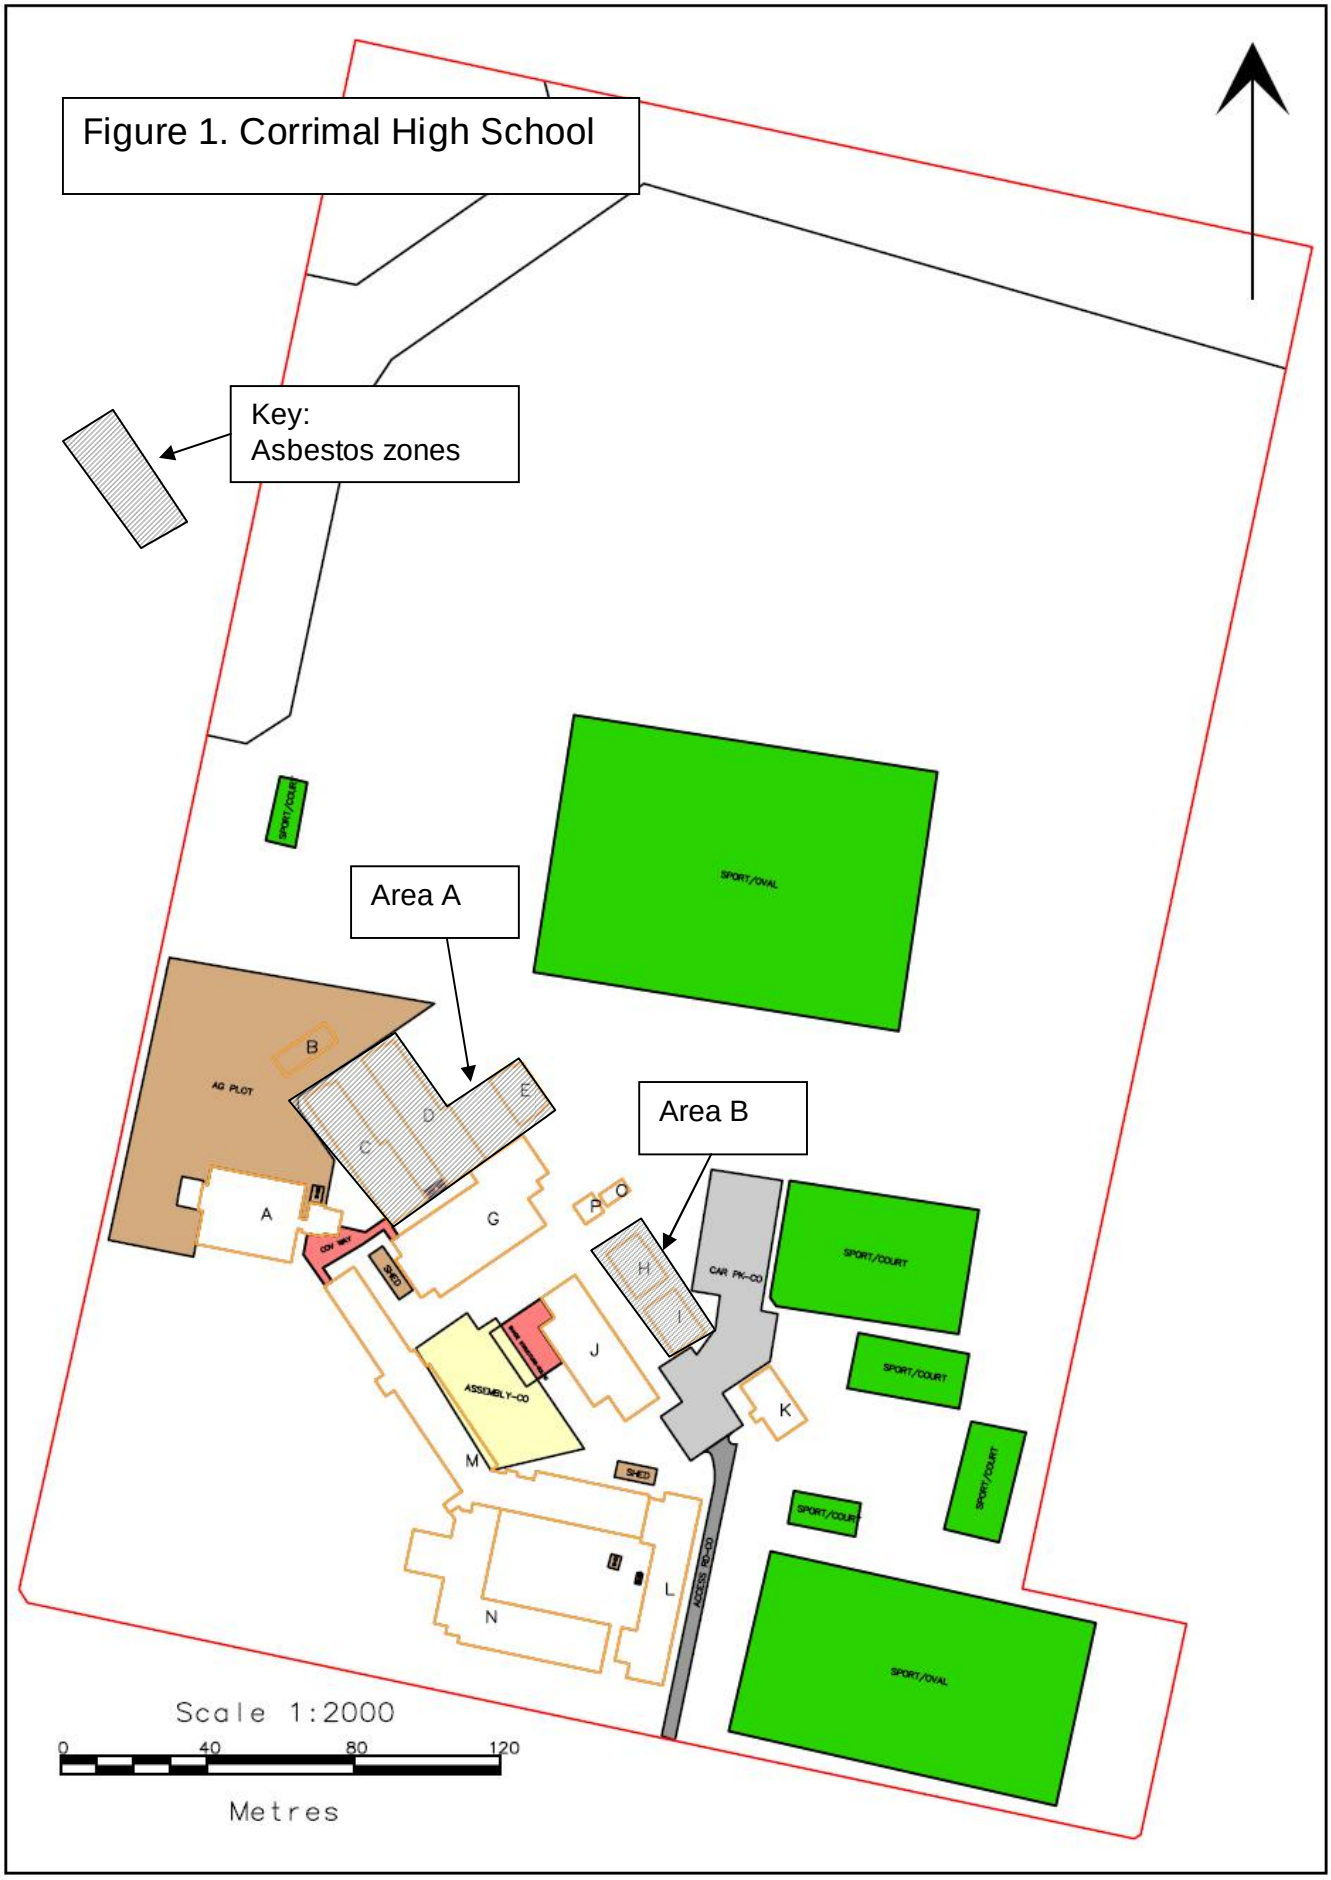
Site Plan (12365)

- Area A – Area around timber classrooms C,D and E
- Area B – Area around timber classrooms H and I

The remediated areas are shown in Figure 1.

Asbestos cement fragments may be present as a component of buried fill within the asbestos zone areas. Refer to Figure 1 site plan. A hygienist should be engaged to determine whether the asbestos within the Asbestos Zones is considered *non friable* or *friable* in accordance with the NSW WorkCover Authority 'Working with Asbestos, 2008'. This contains safety guidelines and requirements for work involving asbestos.

Event	Location	Description of Material	Extent	Condition	Risk Status	Control Priority	Control Recommendation/Comments
School Grounds*							
A	Area around timber classrooms C, D and E	Possible buried asbestos cement fragments	Throughout – below ground surface	Unknown	Low	Low	Provide repair to surface coverage using mulched garden beds as appropriate. Appropriate drainage and fencing may be required. Stop the usage of herbicides to allow grass to grow. Do not disturb soil surface. Inspect every three months or after adverse weather conditions months for signs of surface wear and possible fragments at surface.
B	Area around timber classrooms H and I	Possible buried asbestos cement fragments	Throughout – below ground surface	Unknown	Low	Low	Provide repair to surface coverage using mulched garden beds as appropriate. Appropriate drainage and fencing may be required. Stop the usage of herbicides to allow grass to grow. Do not disturb soil surface. Inspect every three months or after adverse weather conditions months for signs of surface wear and possible fragments at surface.
