Asbestos in Grounds, Asbestos Management Plan, North Rocks Public School, North Rocks, NSW

January 2013

NSW Public Works

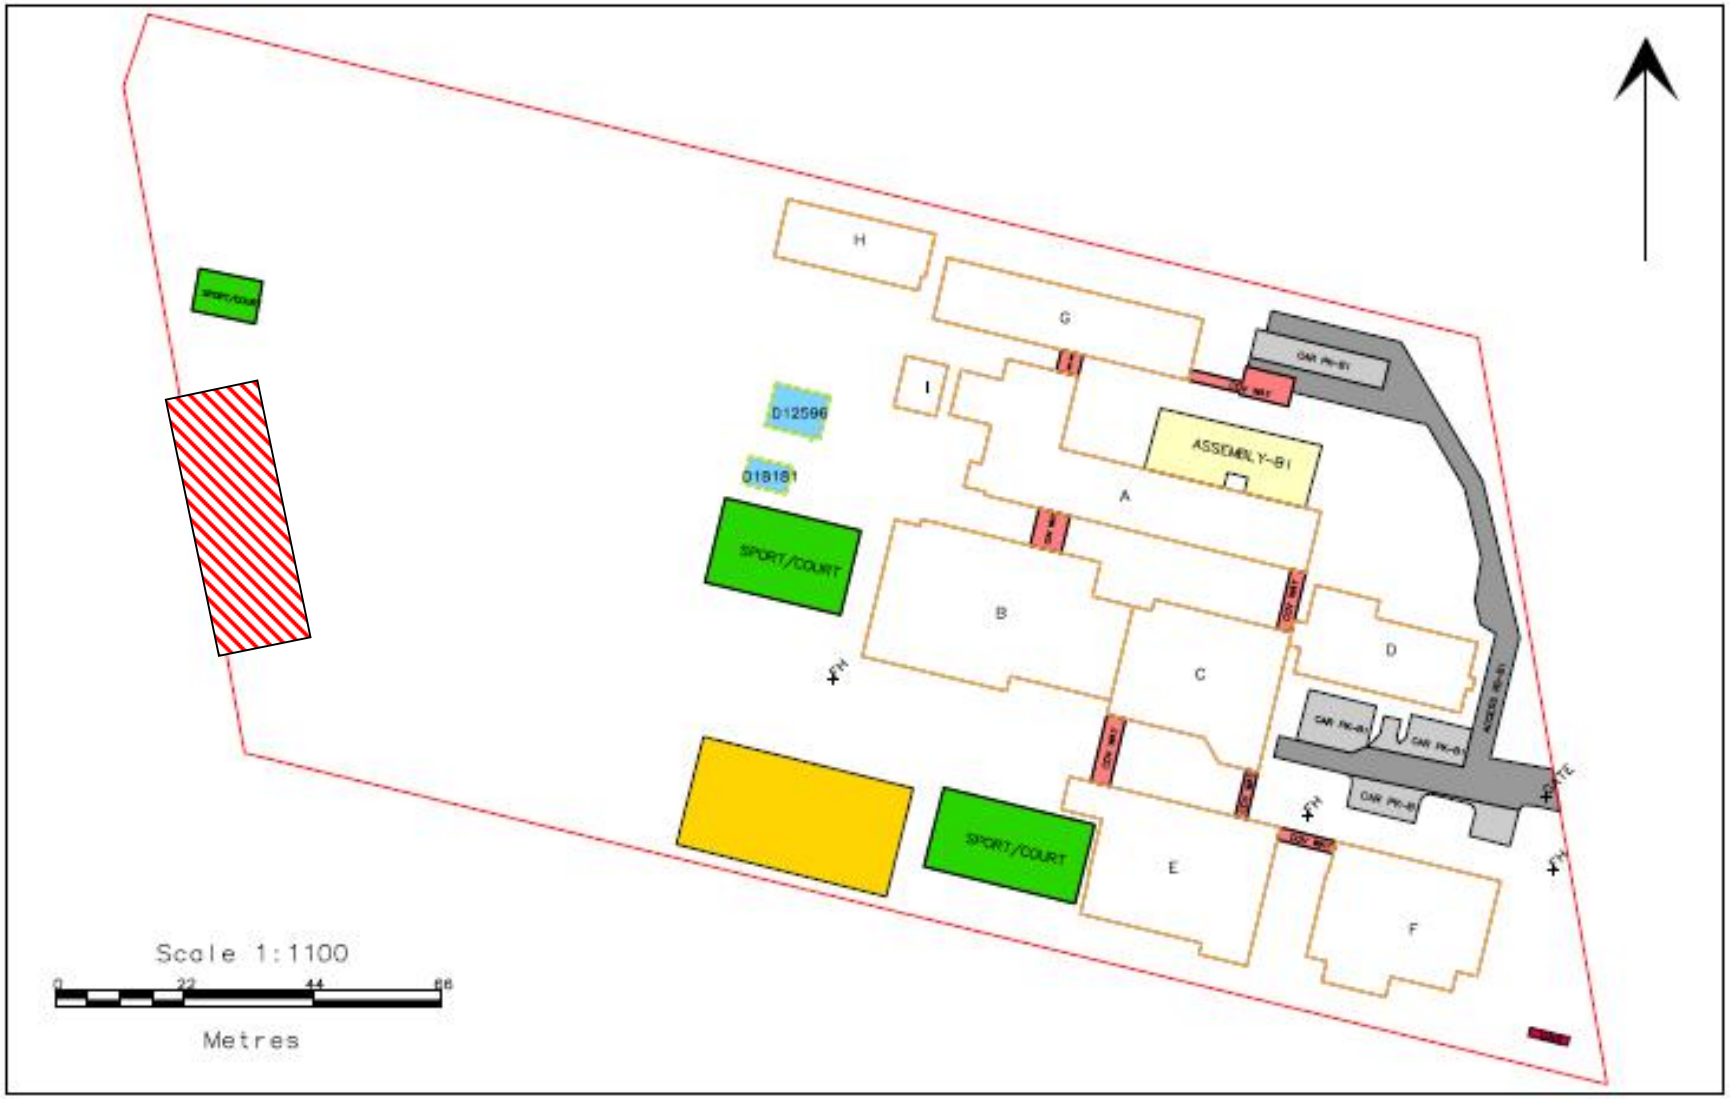
Asbestos cement fragments may be present as a component of buried fill within the asbestos zone areas. Refer to Figure 1 site plan. A hygienist should be engaged to determine whether the asbestos within the Asbestos Zones is considered *bonded* or *friable* in accordance with the NSW WorkCover Authority 'Working with Asbestos, 2008'. This contains safety guidelines and requirements for work involving asbestos.

Event	Location	Description of Material	Extent	Condition	Risk Status	Control Priority	Control Recommendation/Comments
School Grounds*							
A	Western end of playing field	Possible buried asbestos cement fragments	Throughout – below ground surface	Unknown	Low	Low	Maintain existing surface. Do not disturb soil surface Inspect every three months or after adverse weather conditions for signs of surface wear and possible fragments at surface. If further issues arise, drainage, re-turfing and extending hardstand may be considered.

Asbestos Zone
