Asbestos in Grounds, Asbestos Management Plan, St Peters Public School, St Peters, NSW

March 2013

NSW Public Works

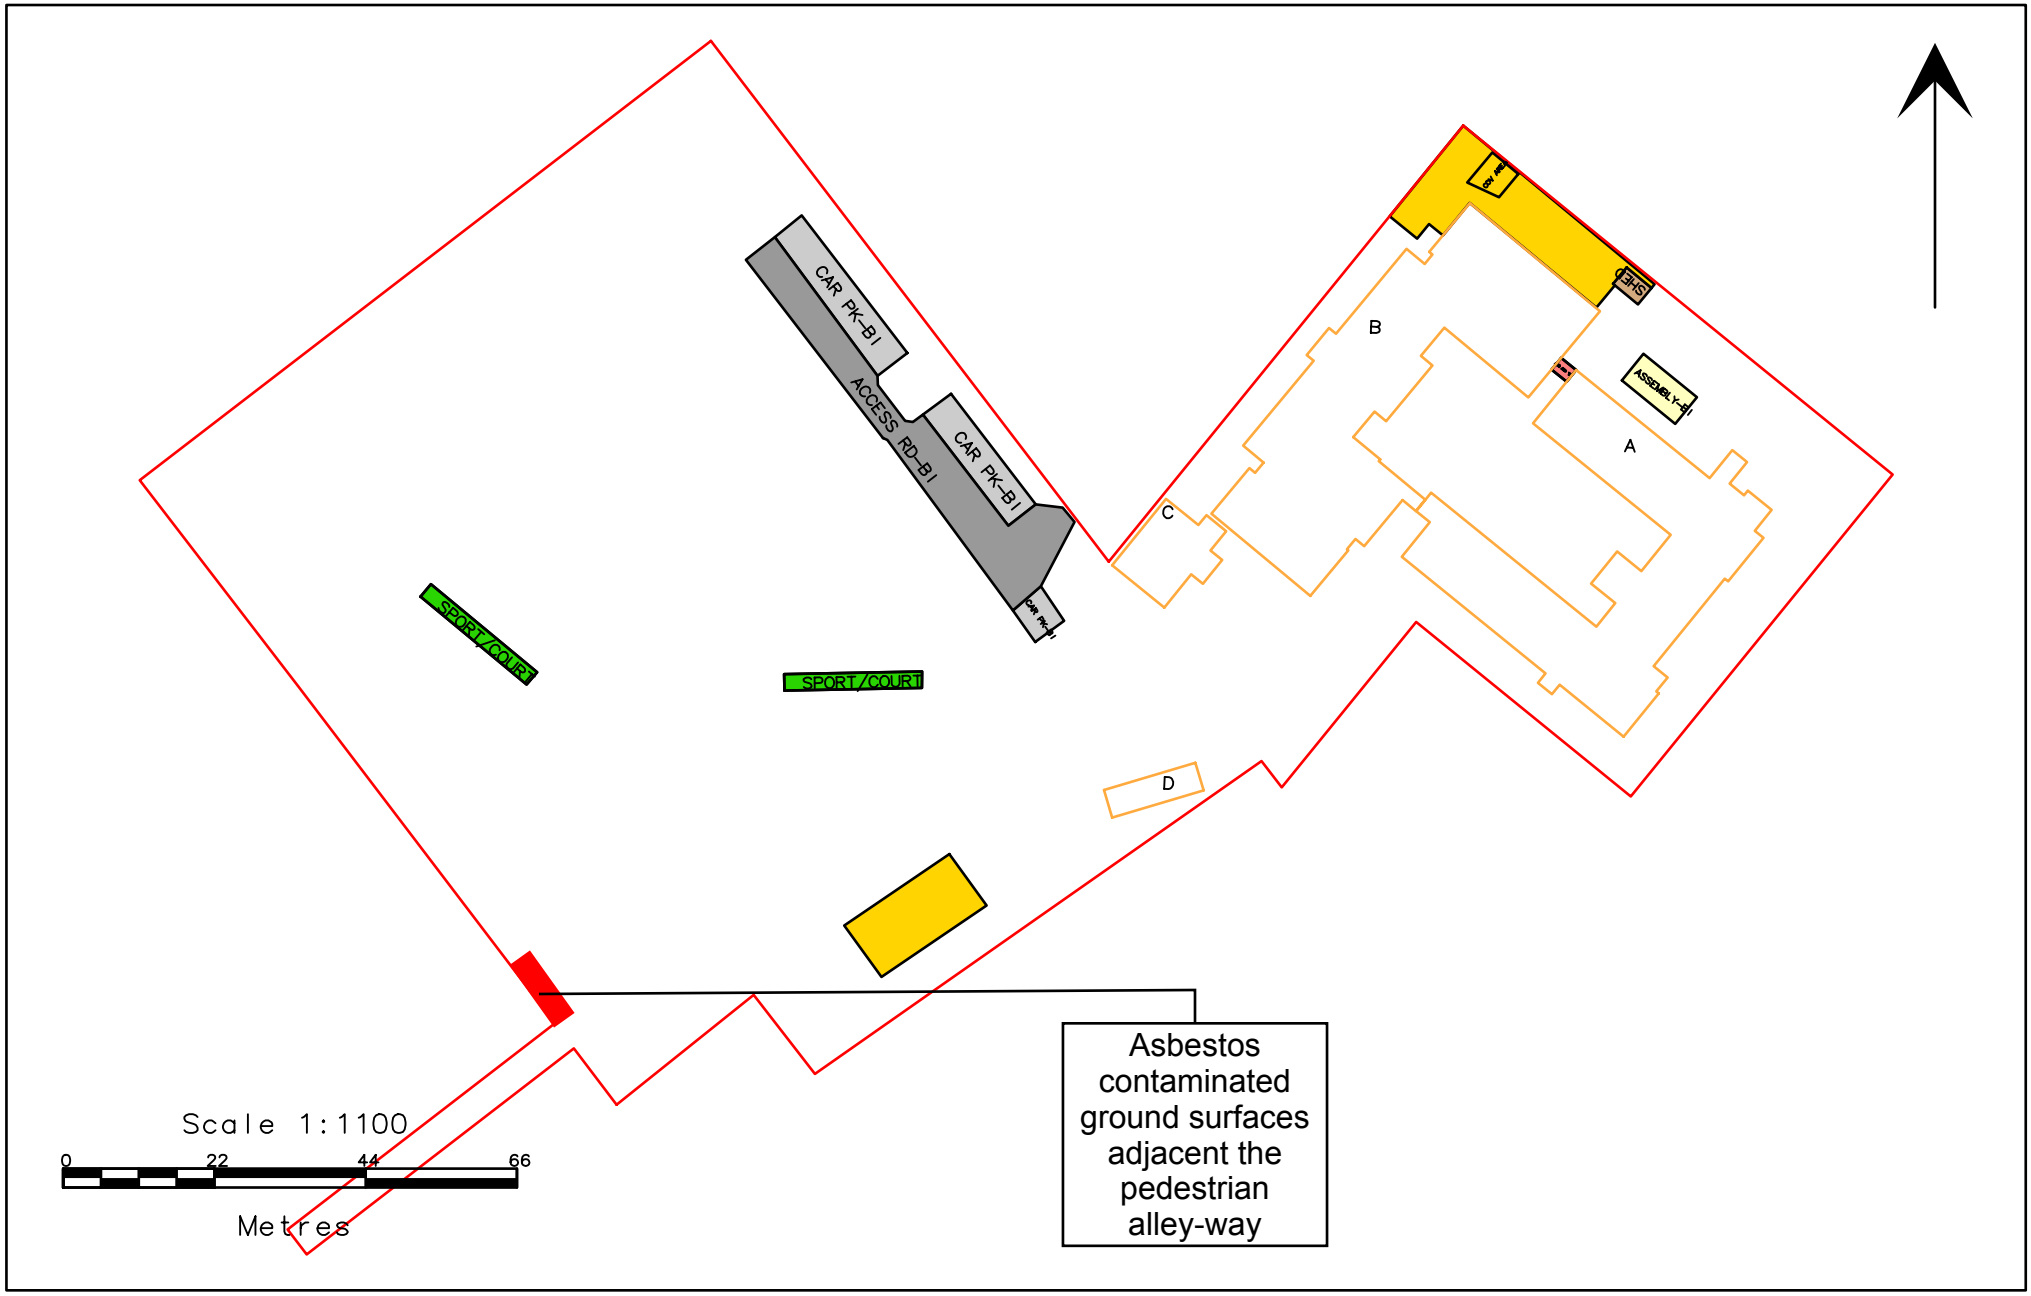
Site Plan (11271)

The remediated areas are shown in Figure 1.

Asbestos cement fragments may be present as a component of buried fill within the asbestos zone areas. Refer to Figure 1 site plan. A hygienist should be engaged to determine whether the asbestos within the Asbestos Zones is considered *non friable* or *friable* in accordance with the NSW WorkCover Authority 'Working with Asbestos, 2008'. This contains safety guidelines and requirements for work involving asbestos.

Event	Location	Description of Material	Extent	Condition	Risk Status	Control Priority	Control Recommendation/Comments
School Grounds*							
A	South western playground area adjacent to the pedestrian alley-way.	Possible buried asbestos cement fragments	Throughout – below ground surface	Unknown	Medium	Medium	The grounds surfaces should be encapsulated with turf to prevent migrating fibre cement fragments within the soil to reach the ground surfaces. The encapsulated ground surfaces should be inspected by a hygienist to confirm the potential asbestos contaminated soil has been sealed. Gaps at the bottom of the south-western fence-line of the south-west playground area adjacent to 37 Silver Street, St Peters NSW should be sealed appropriately with treated timber planks to prevent further potential asbestos contamination entering from the neighbouring property. The area should be regularly monitored for any fragments and a record kept of how many fragments are found and at what frequency. Fragments should be collected and disposed of as asbestos waste.
