Asbestos in Grounds, Asbestos Management Plan, Terrigal High School, Terrigal NSW

September 2012

NSW Public Works

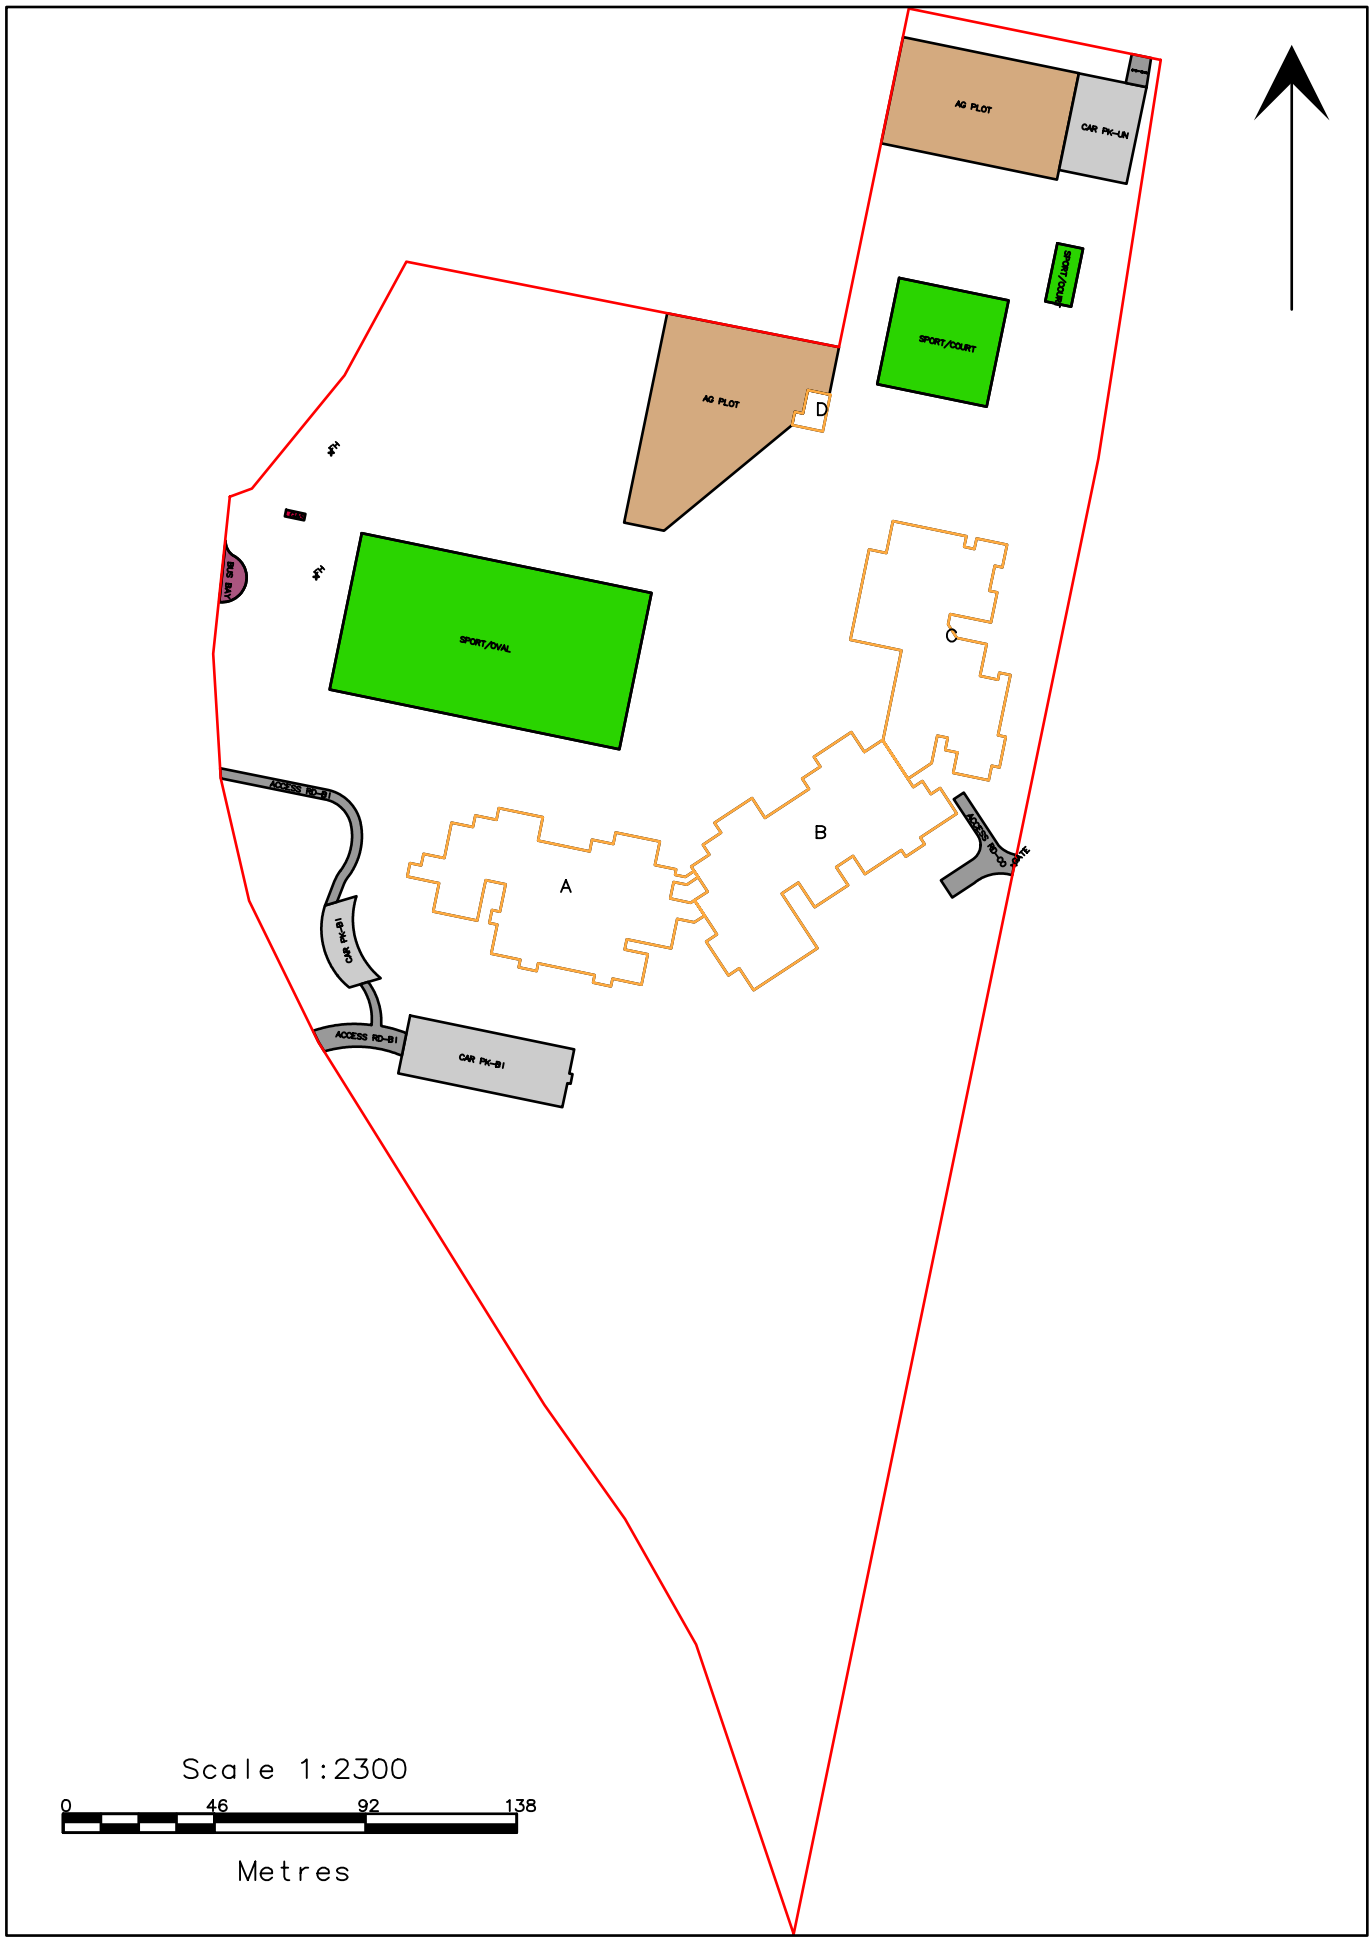
The school site plan is shown in Figure 1. However the exacted location of the asbestos impacted area is not known by PB at this time.

Asbestos cement fragments may be present as a component of buried fill within the asbestos zone areas. Refer to Figure 1 site plan. A hygienist should be engaged to determine whether the asbestos within the Asbestos Zones is considered *non friable* or *friable* in accordance with the NSW WorkCover Authority 'Working with Asbestos, 2008'. This contains safety guidelines and requirements for work involving asbestos.

Event	Location	Description of Material	Extent	Condition	Risk Status	Control Priority	Control Recommendation/Comments
School Grounds*							
A	Chicken enclosure	Possible buried asbestos cement fragments	Throughout – below ground surface	Unknown	Low	Low	No further fibrous cement fragments have been identified since the clearance was undertaken. The area should be inspected on an annual basis for fibrous cement fragments.
