CRINGILA PUBLIC SCHOOL INDOOR AIR QUALITY RISK ASSESSMENT

Summary Report
24/08/2020 – 04/09/2020

NSW Department
of Education

Cringila Public School

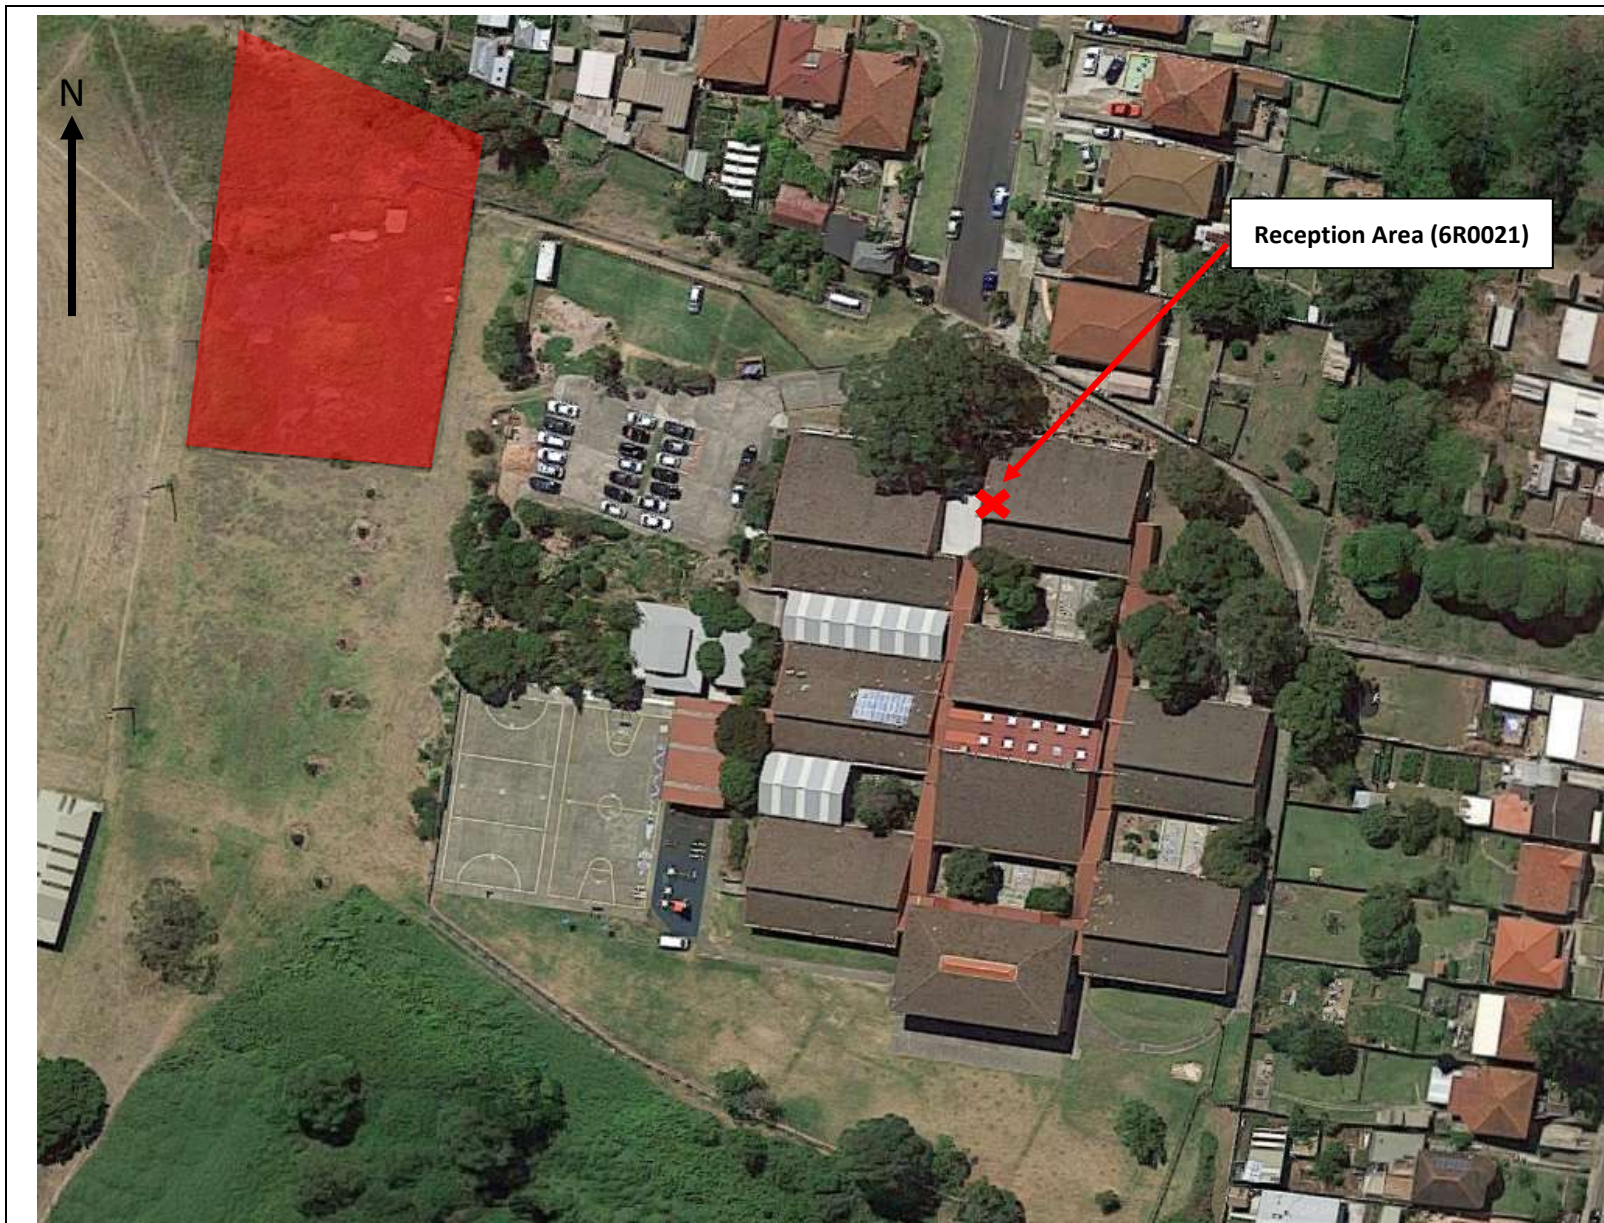
Appendix A: Site Map and Sampling Location

- ✘ Air Quality Monitoring Location
- Northwest Hotspot Investigation Area

Site	Cringila Public School
Monitoring Location	Reception Area (6R0021)
Date	24 th August 2020 – 4 th September 2020
Job Number	J153825-04
Report	AMR-IAQ-05
Version	1.0
