AIR MONITORING RISK ASSESSMENT  
CRINGILA PUBLIC SCHOOL - NW HOTSPOT  
35 SHEFFIELD STREET  
CRINGILA NSW 2502

Weekly Report  
11/06/18 - 15/06/18

Document Quality Management Details.		
<b>Report Name:</b>	AMR-29 Air Monitoring Risk Assessment	
<b>Site Details:</b>	Cringila PS NW Hotspot – 35 Sheffield Street, Cringila NSW 2502	
<b>Client Name:</b>	NSW Department of Education	
<b>Client Number:</b>	C107826	
<b>Signatures:</b>	Prepared By:

# Air Monitoring Risk Assessment

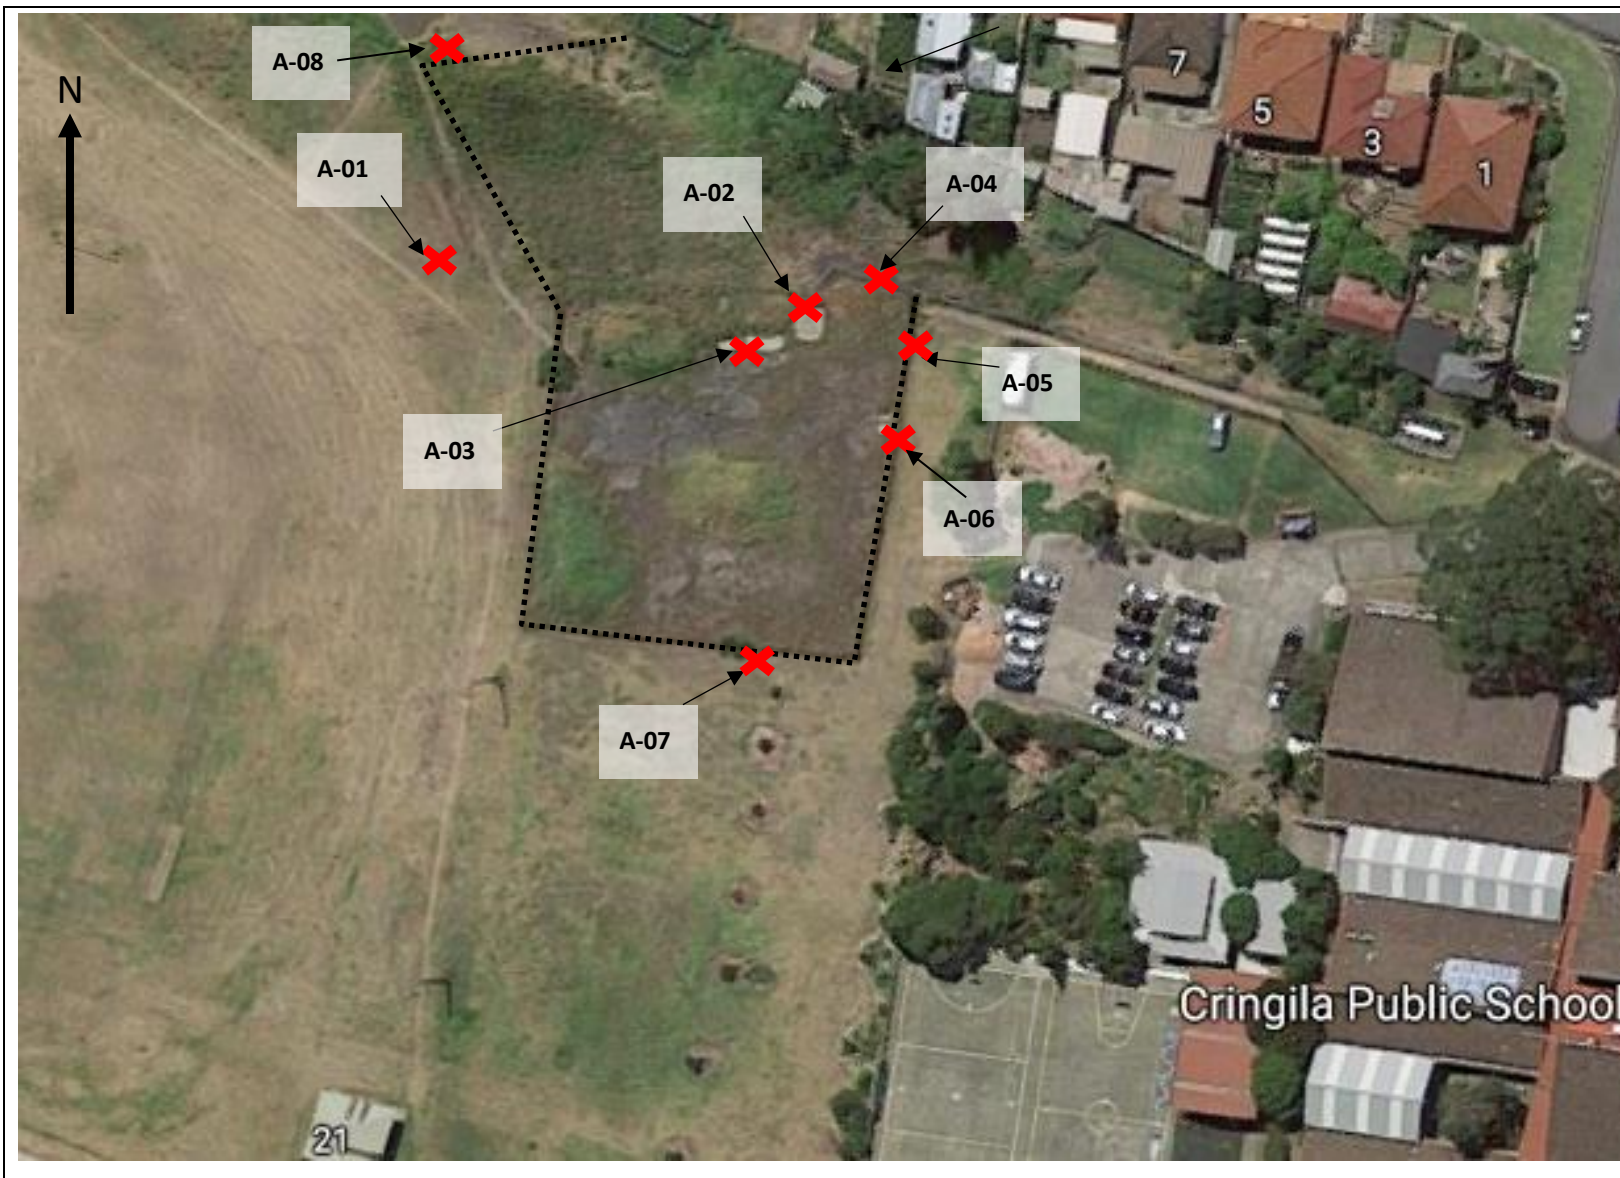
### **Appendix A: Site Map and Sampling Locations**

Spot measurements were taken within the North-Western Hotspot area and at surrounding locations to determine whether potential air pollutants from the subsurface hotspot were present. These monitoring locations included the following:

- A-01 General Background
- A-02 NW Hotspot – Concrete Cap Surface
- A-03 NW Hotspot – Small Mound
- A-04 NW Hotspot – NE fence line
- A-05 Exclusion Area Fence Line East of Hotspot (Approx. 10m)
- A-06 Exclusion Area Fence Line Southeast of Hotspot (Approx. 15m)
- A-07 Exclusion Area Fence Line South of Hotspot (Approx. 30m)
- A-08 Exclusion Area Fence Line Northwest of Hotspot, adjacent 17 Lackawanna Street (Approx. 50m)

The atmospheric pollutant results for each monitoring event are summarised below in Table 3, and locations can be viewed in **Appendix A**.
