# Asbestos in Grounds Management Plan, Windang Public School, Windang, NSW

January 2013

NSW Public Works

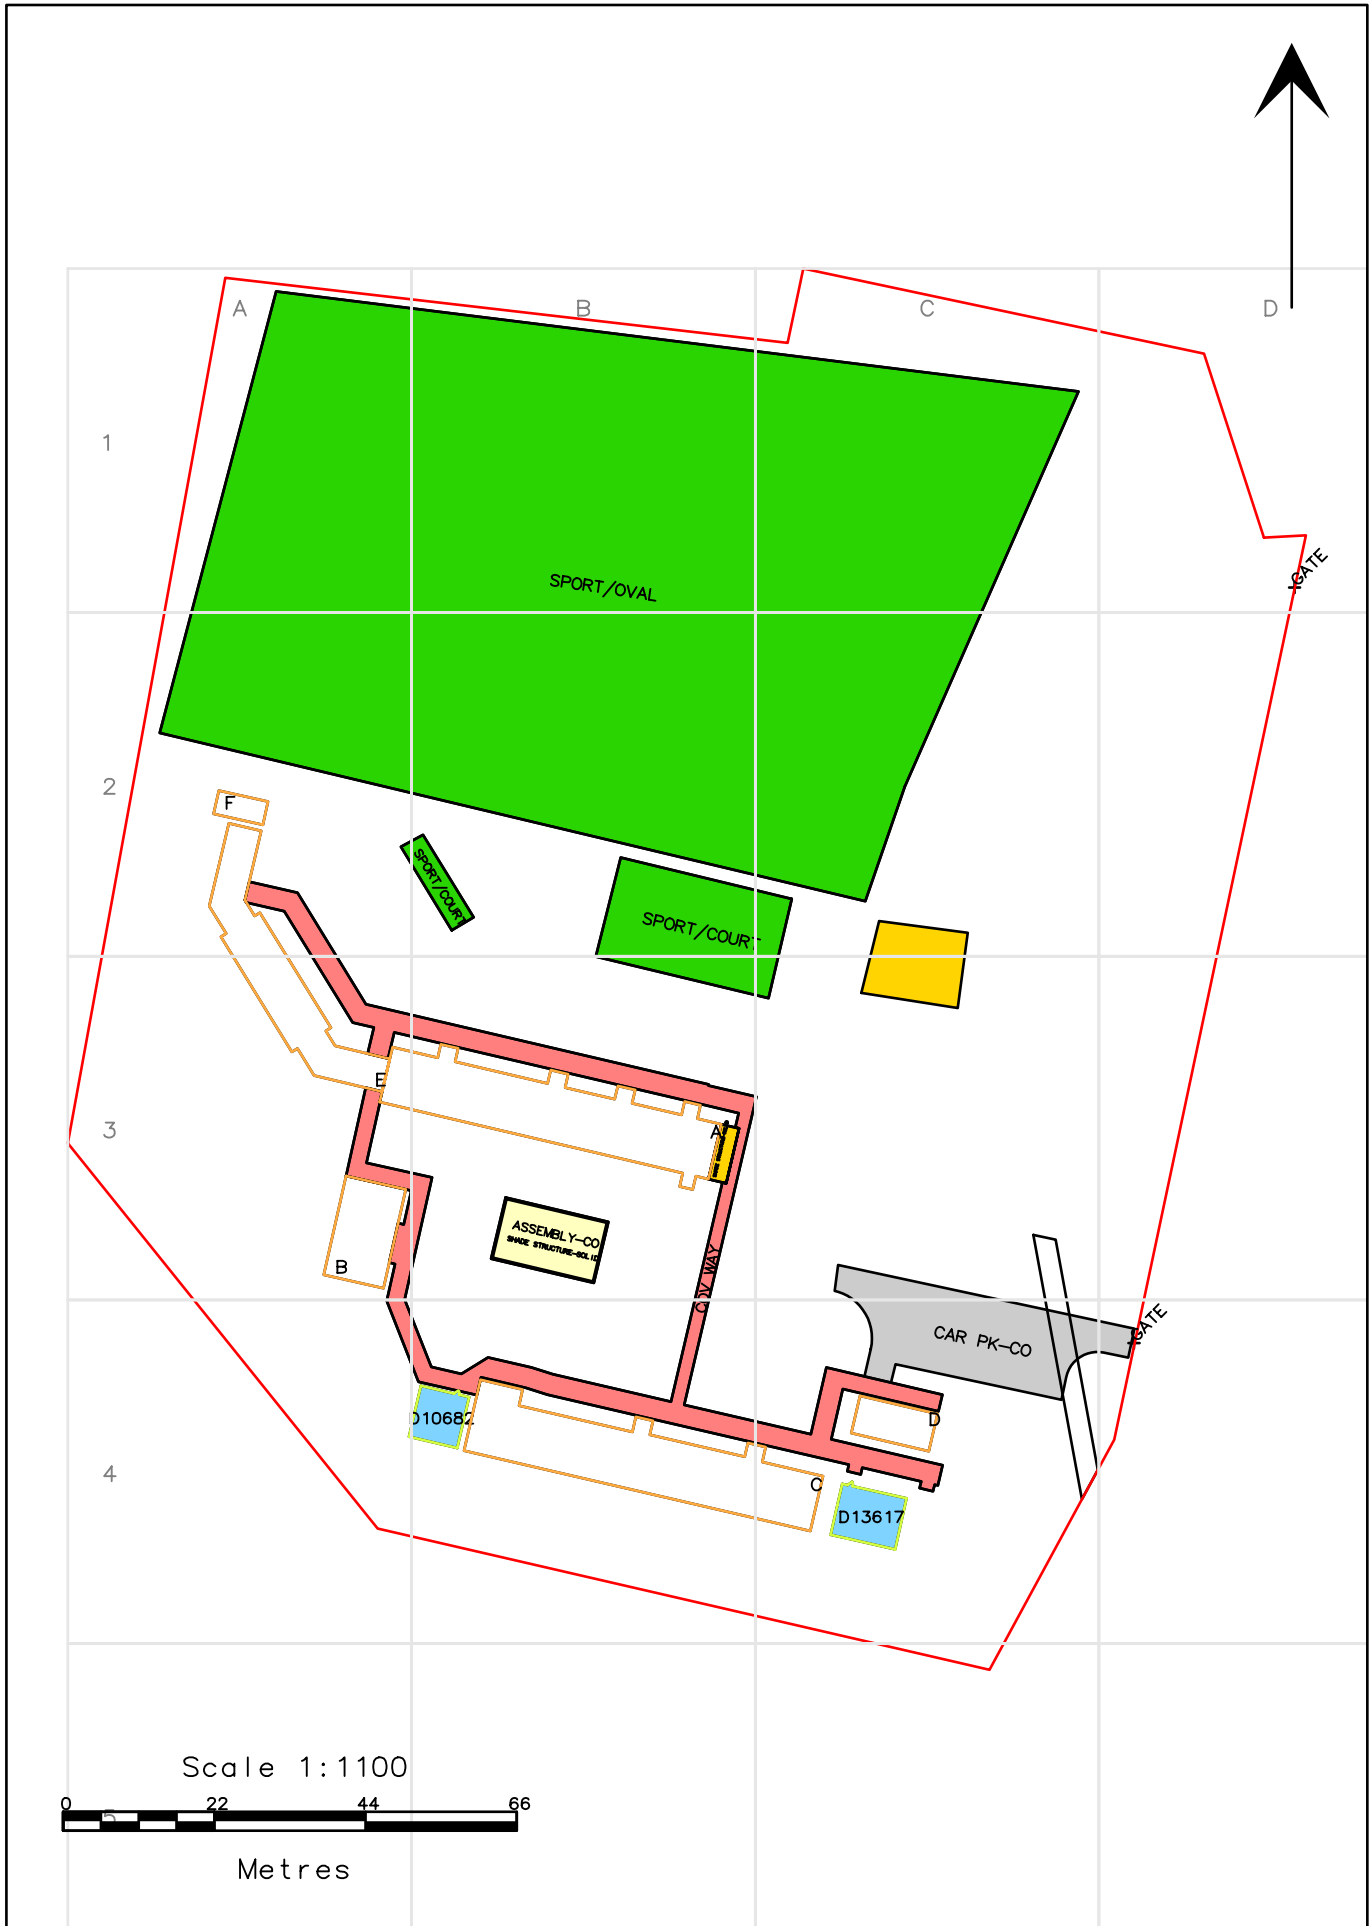
# 1992 — Windang Public School Site Plan (12905)

- **Area A** – Area between seating area, COLA and car park
- **Area B** – Area between gate and car park on road site of site
- **Area C** – Area between school buildings and school oval
- **Area D** – Areas around demountable units at Windang Public School, Oakland Avenue, Windang NSW 2528.

The remediated areas shown in Figure 1.

Asbestos cement fragments may be present as a component of buried fill within the asbestos zone areas. Refer to Figure 1 site plan. A hygienist should be engaged to determine whether the asbestos within the Asbestos Zones is considered *bonded* or *friable* in accordance with the NSW WorkCover Authority 'Working with Asbestos, 2008'. This contains safety guidelines and requirements for work involving asbestos.

Event	Location	Description of Material	Extent	Condition	Risk Status	Control Priority	Control Recommendation/Comments
<i>School Grounds*</i>							
A	Area between seating area, COLA and carpark	Possible buried asbestos cement fragments	Throughout – below surface ground	Unknown	Low	Low	Provide repair to surface coverage using turf and/or mulched as appropriate. Do not disturb soil surface. Inspect every three months or after adverse weather conditions months for signs of surface wear and possible fragments at surface.
B	Area between gate and car park on road site of site	Possible buried asbestos cement fragments	Throughout – below surface ground	Unknown	Low	Low	Provide repair to surface coverage using turf and/or mulched as appropriate. Do not disturb soil surface. Inspect every three months or after adverse weather conditions months for signs of surface wear and possible fragments at surface.

C	Area between school buildings and school oval	Possible buried asbestos cement fragments	Throughout – below surface ground	Unknown	Low	Low	Provide repair to surface coverage using turf and/or mulched as appropriate. Do not disturb soil surface. Inspect every three months or after adverse weather conditions months for signs of surface wear and possible fragments at surface.
D	Areas around demountable units	Possible buried asbestos cement fragments	Throughout – below surface ground	Unknown	Low	Low	Provide repair to surface coverage using turf and/or mulched as appropriate. Do not disturb soil surface. Inspect every three months or after adverse weather conditions months for signs of surface wear and possible fragments at surface.

\*Refer to Figure 1 for detail of the area locations
