# **Asbestos in Grounds, Asbestos Management Plan, Hunters Hill High School, Hunters Hill, NSW**

March 2014

**NSW Public Works**

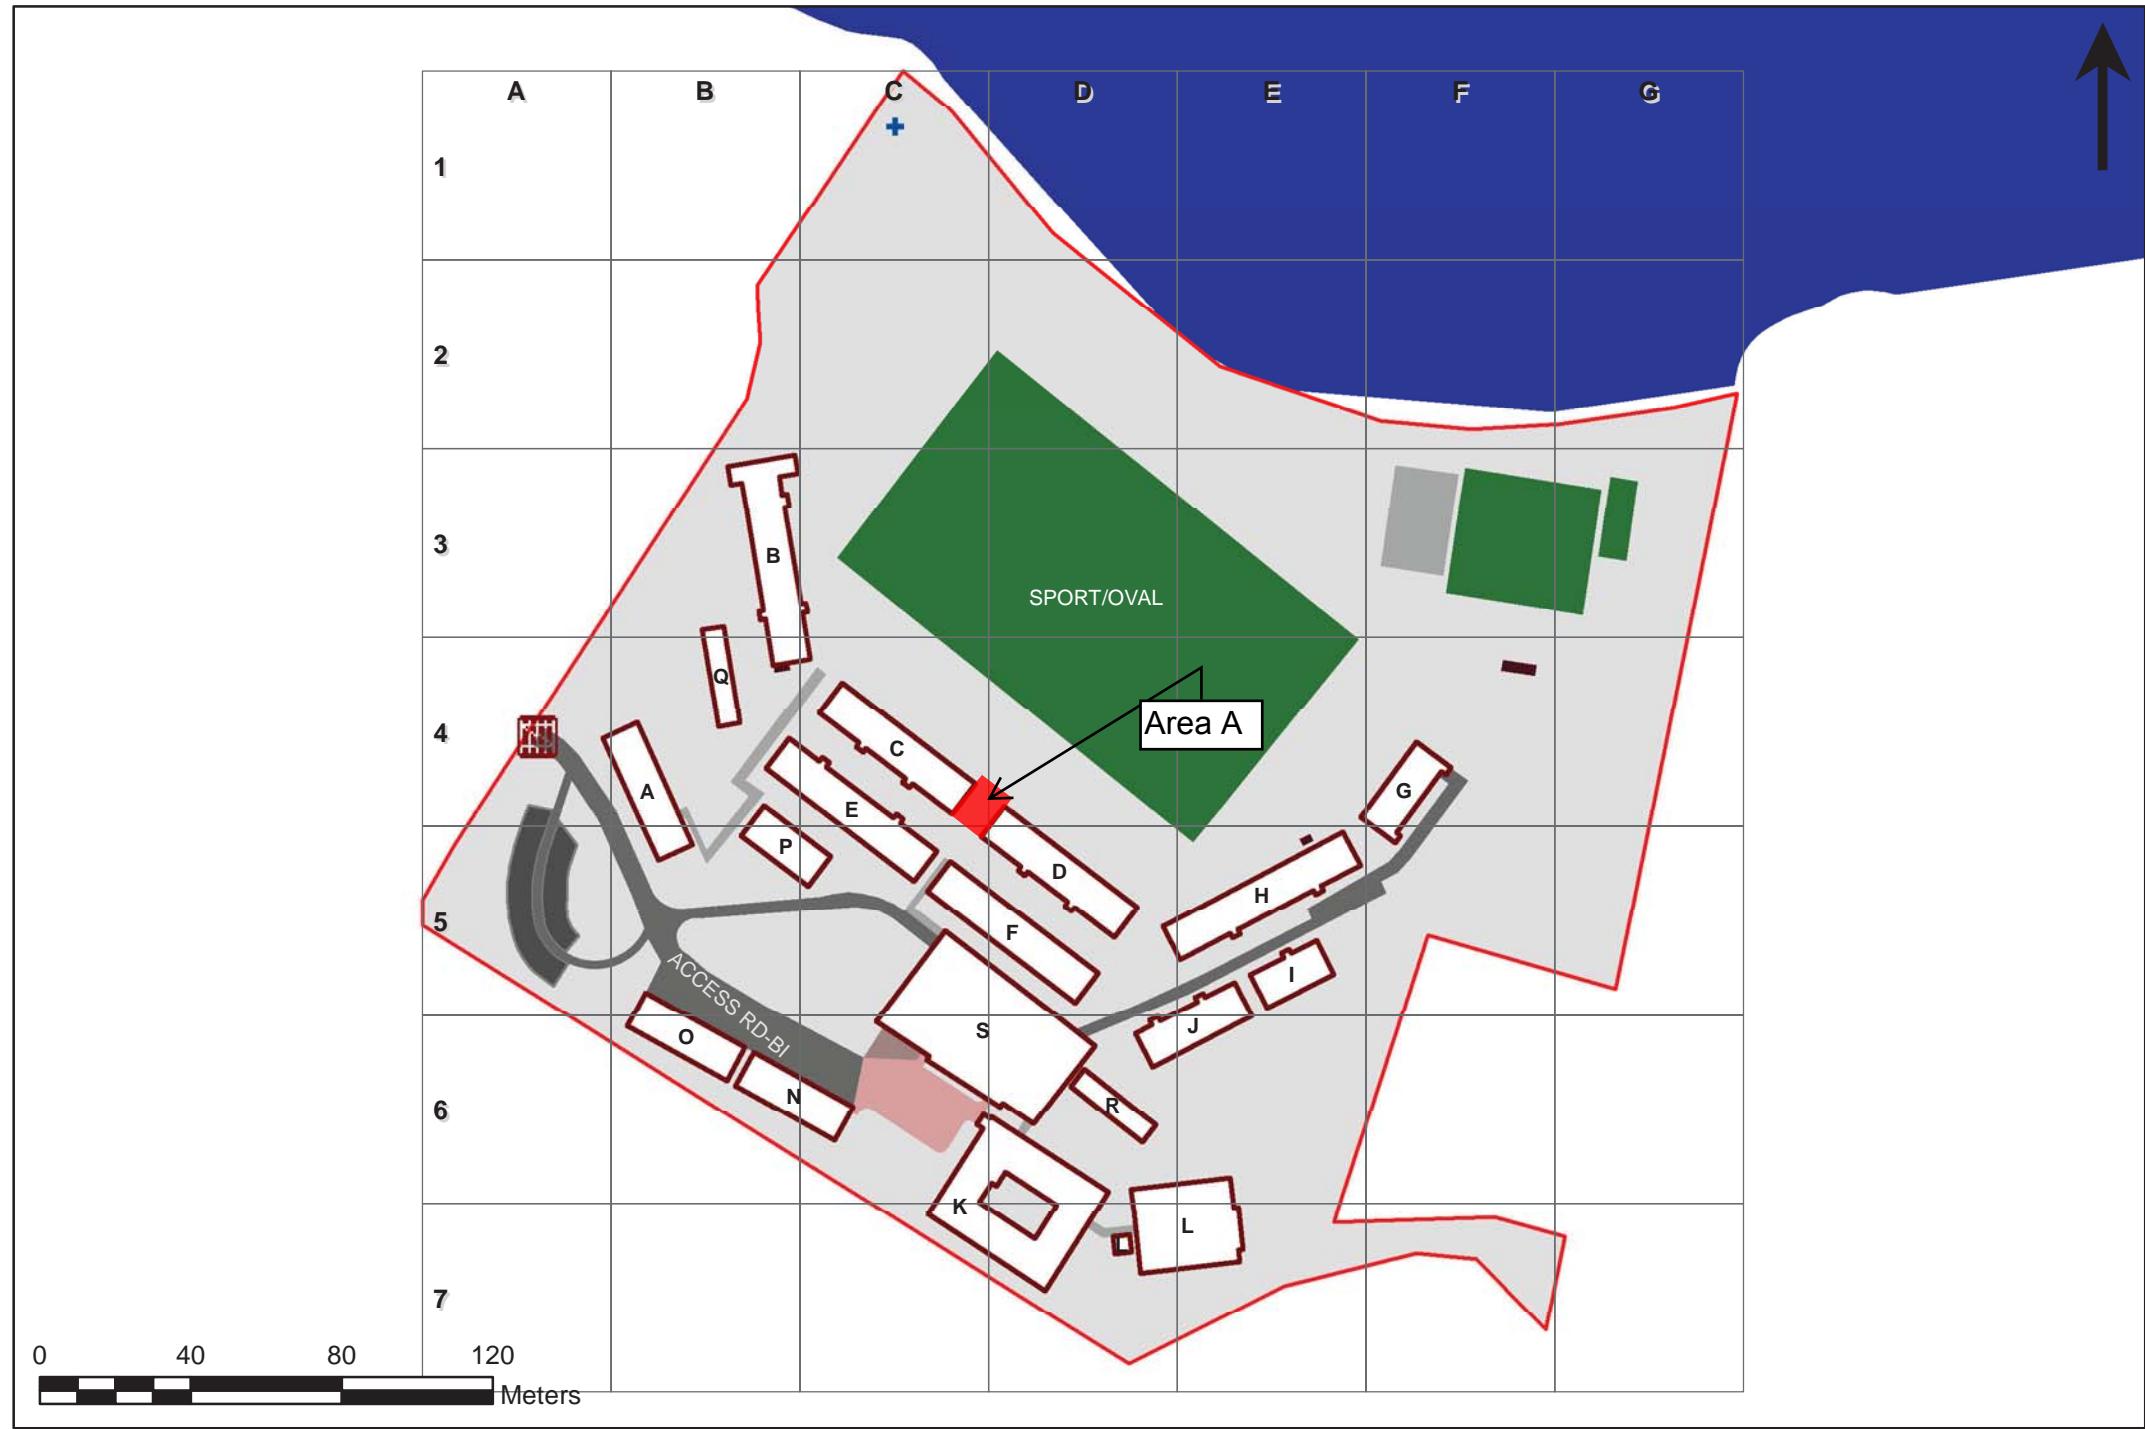
8207 - Hunters Hill High School  
Site Plan (11015)

The remediated areas are shown in Figure 1.

Asbestos cement fragments may be present as a component of buried fill within the asbestos zone areas. Refer to Figure 1 site plan.

| Event | Location | Description of Material | Extent | Condition | Risk Status | Control Priority | Control Recommendation/Comments |
|---|--|---|---|---|---|---|--|
| A | Thoroughfare between buildings C and D | Possible buried asbestos cement fragments | Throughout – below ground surface | Unknown | Low | Low | <p>Restrict the area to students.</p> <p>Due to water movement, foot traffic and lack of sunlight, grass is not expected to recover in the area. A layer of geo-fabric may be pinned to prevent the moment of soil whilst allowing water flow. The geo-fabric can be covered with a layer of synthetic turf, or with an alternative material for added protection.</p> <p>A long term solution utilising a hardstand material is also an option for the area.</p> <p>Inspect the area for fragments yearly post remediation.</p> |
